# YEOVIL St John the Baptist

**Quinquennial Inspection for the Year 2017**

Inspection of Churches Measure 1955  
Quinquennial Inspection Report  
Diocese of Bath and Wells

May 2017

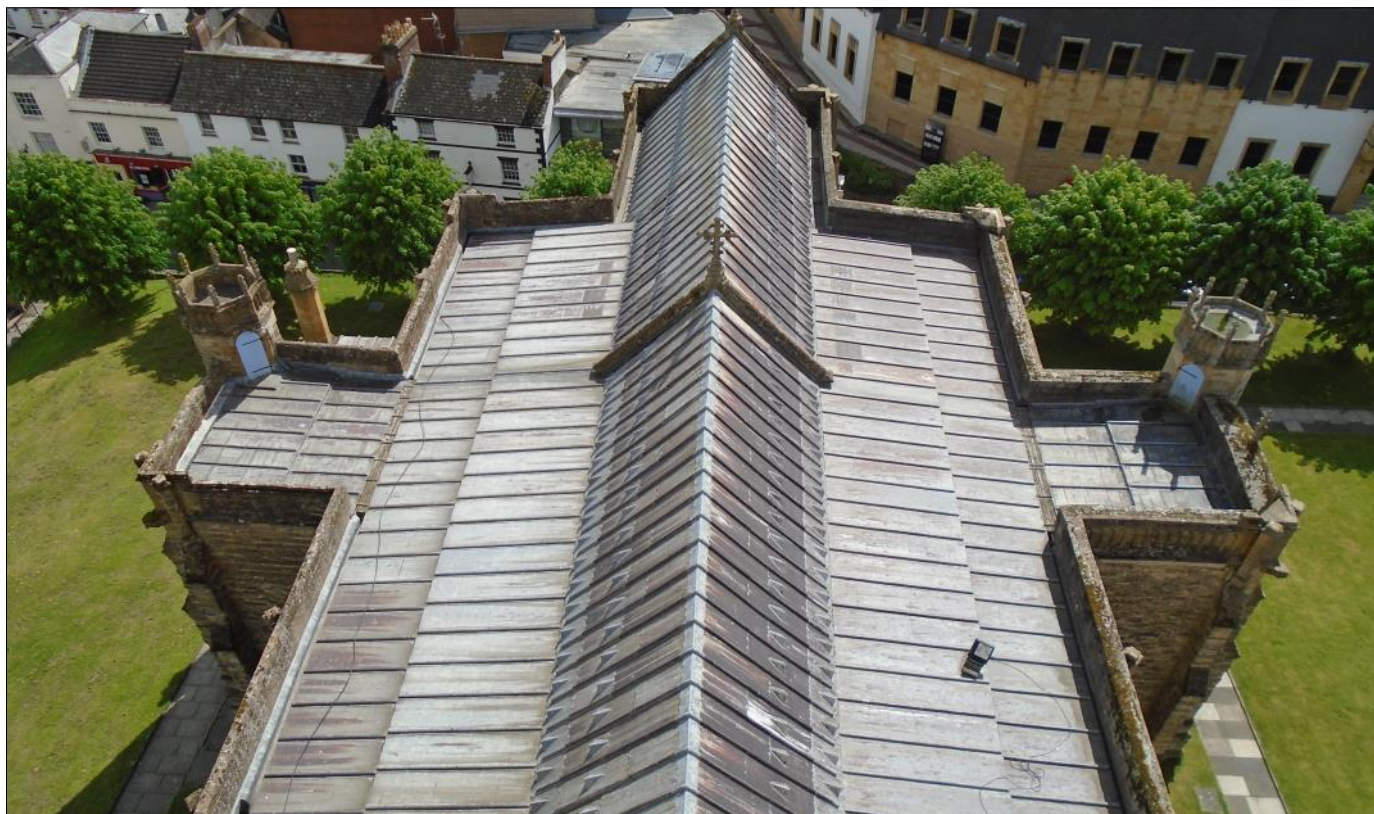
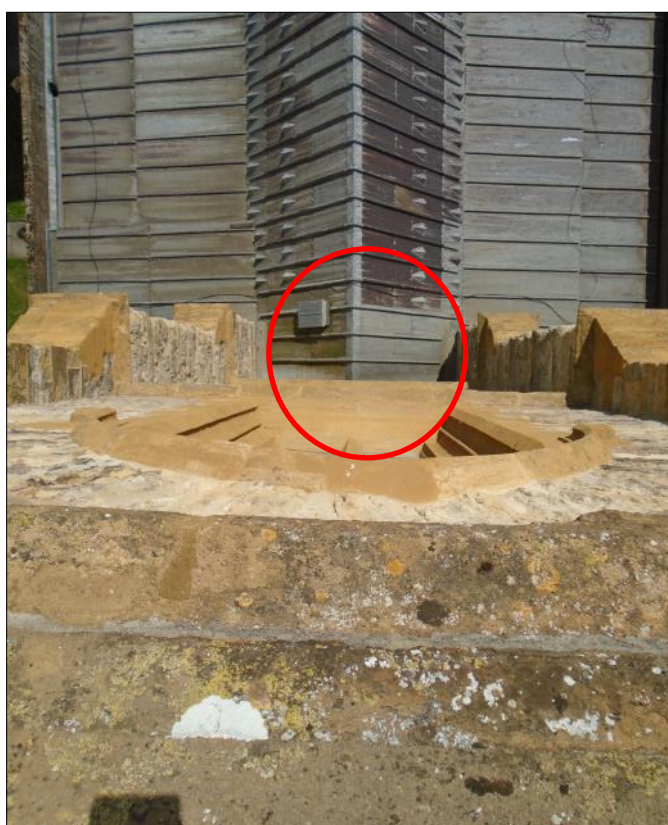
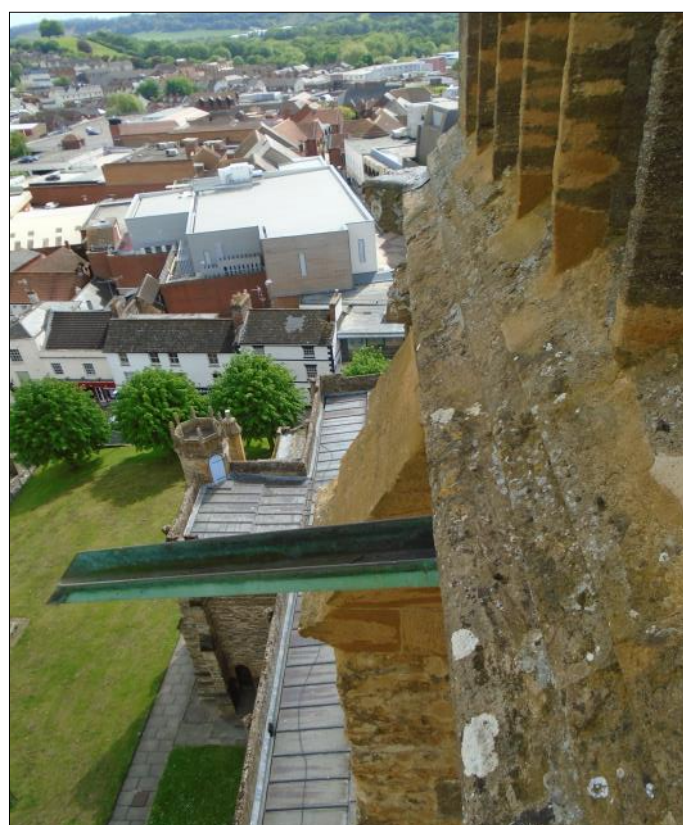
**Top:** General view of nave, side aisle, transept and chancel roofs.  
**Below left:** Access hatch on N side of nave roof, note end bays exclude vents.  
**Below right:** Gargoyle draining tower roof, note mortar repairs to parapets.

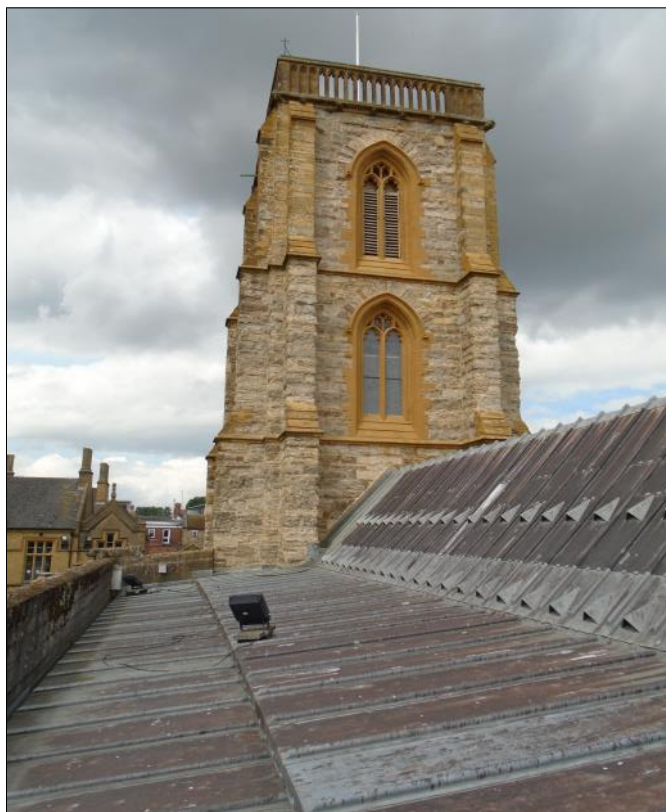
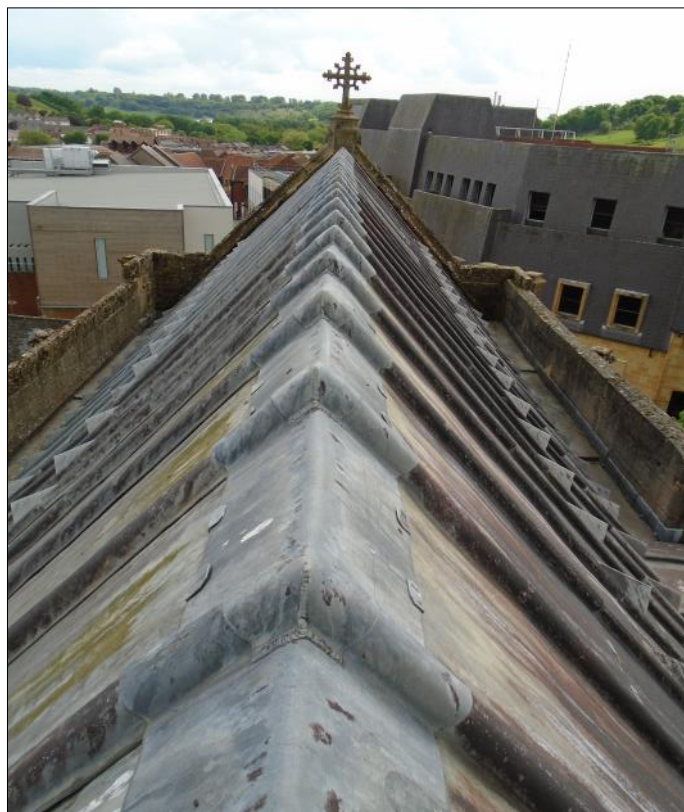
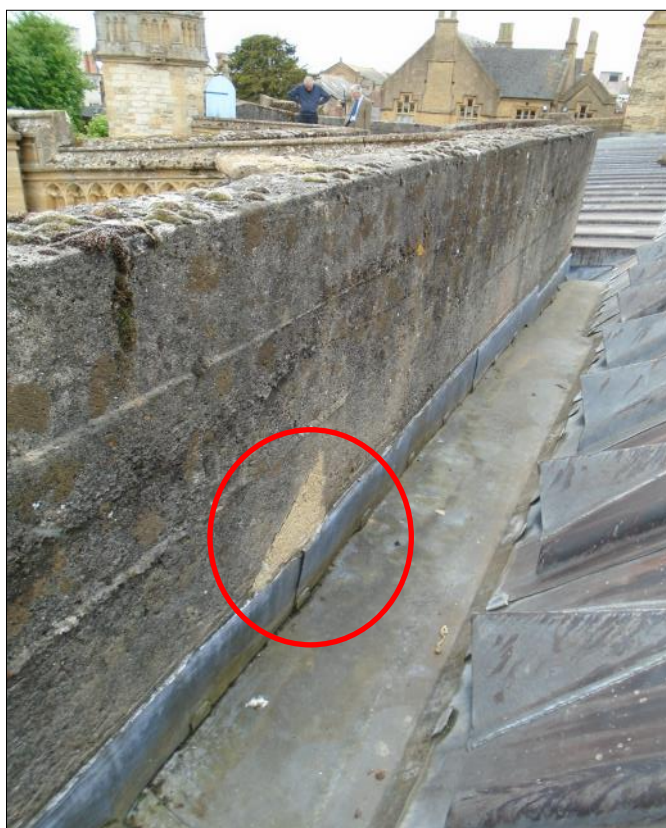
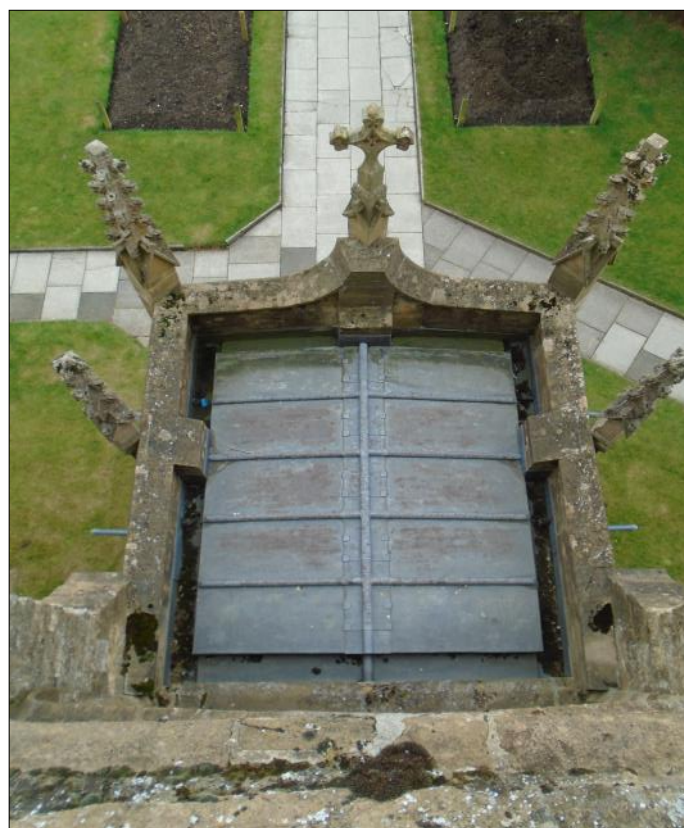
- Top left:** General view of S aisle and nave roofs with repaired tower beyond.  
**Top right:** Lead capping to rolled ridge and continuous rolls over chancel roof.  
**Below left:** Concrete failings to southern parapets will need local repairs.  
**Below right:** Narrow gutters to S porch are easily blocked and need regular clearance.

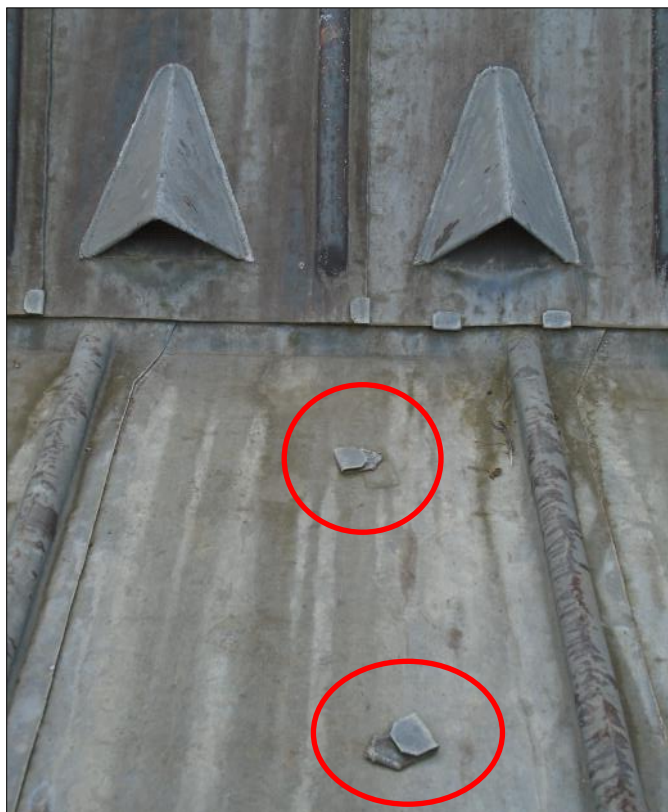
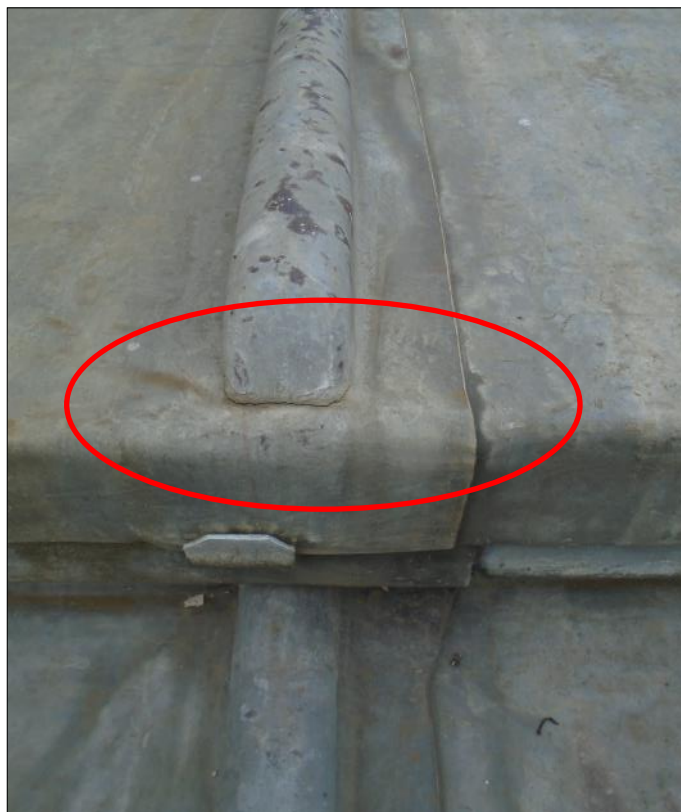
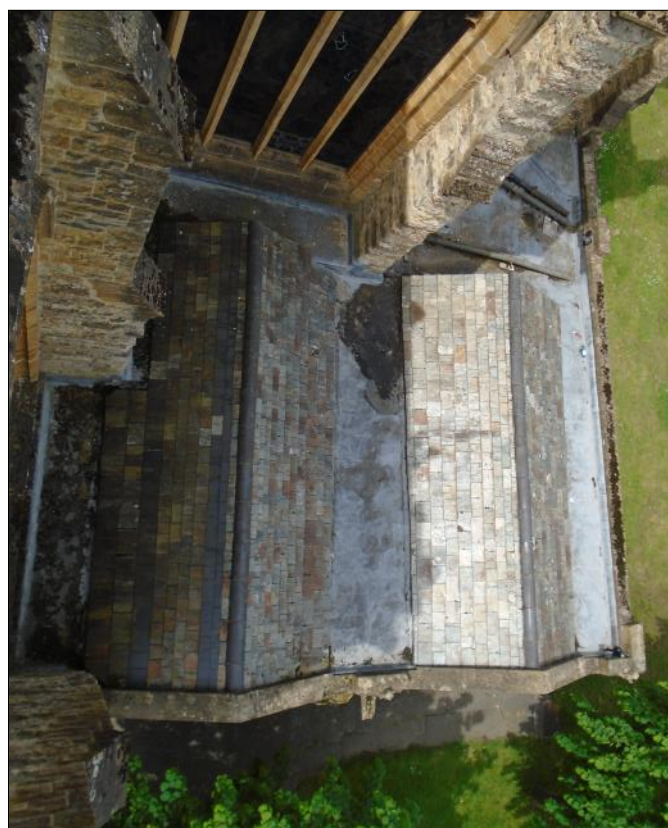
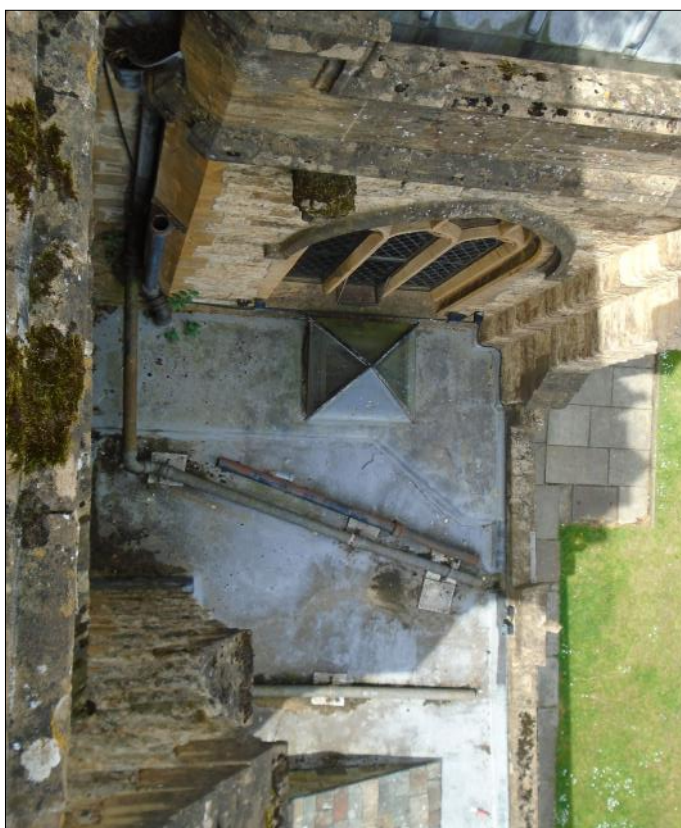
- Top left:** Lead clips on N chancel roof, location unknown and none missing.  
**Top right:** Repair cracks along leading edge of lead rolls.  
**Below left:** Regularly check low level flat roofs over vestry, asphalt repairs.  
**Below right:** Remove debris and vegetation over vestry roofs.

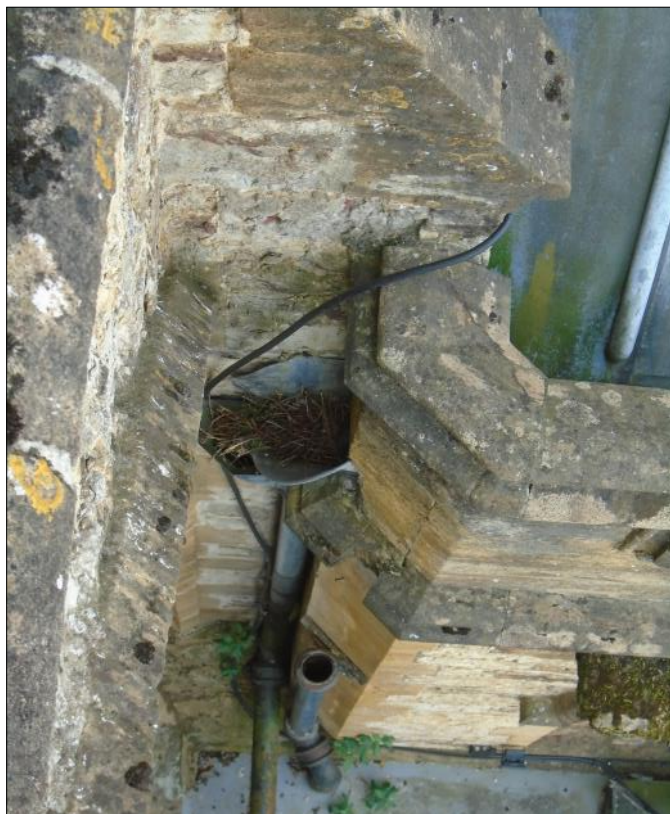
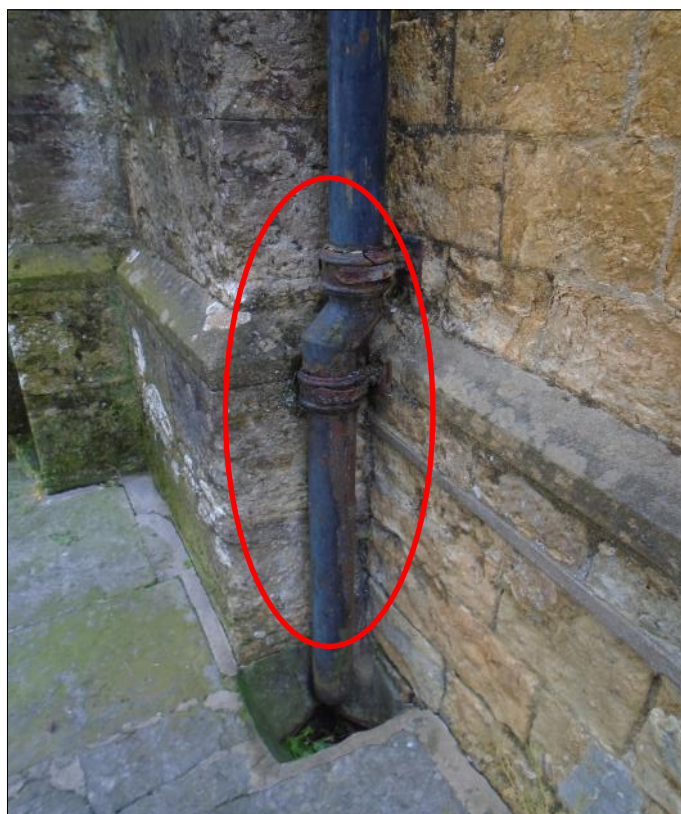
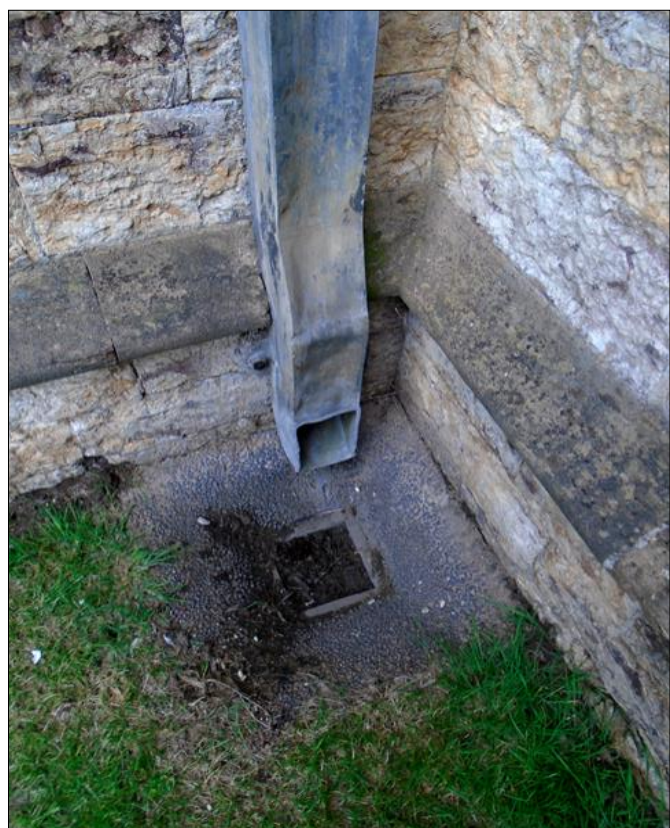
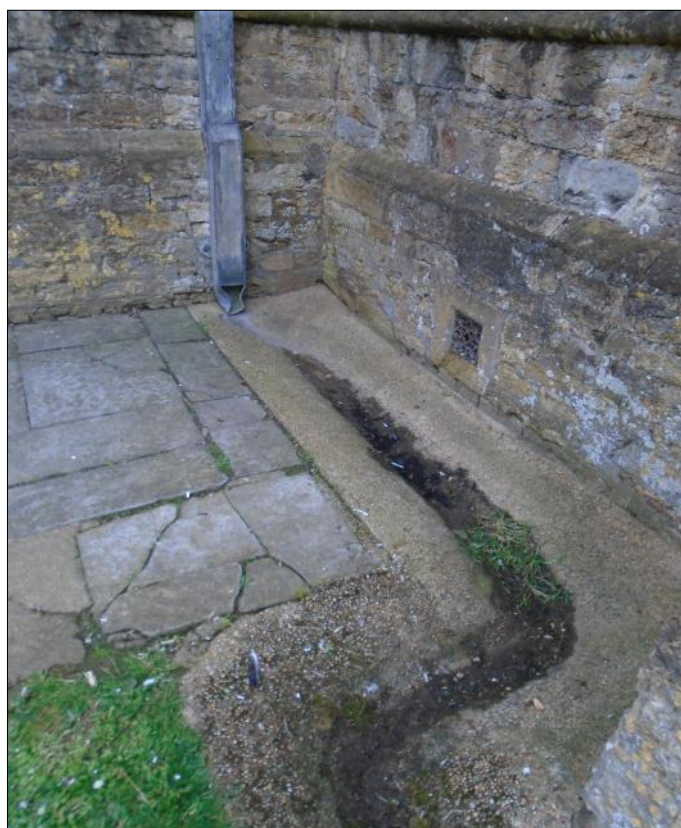
- Top left:** Clear birds nest from hopper on E side of organ chamber roof.  
**Top right:** Replace cracked and corroding lengths of downpipe.  
**Below left:** Keep gulleys clear and point perimeter joint to wall.  
**Below right:** Maintain ground gutters and keep clear.

- 8.10. The base of the east vestry downpipe is in poor condition with cracked collars and corroded fixings; these should be replaced to prevent the walls behind coming saturated which in turn leads to internal dampness.

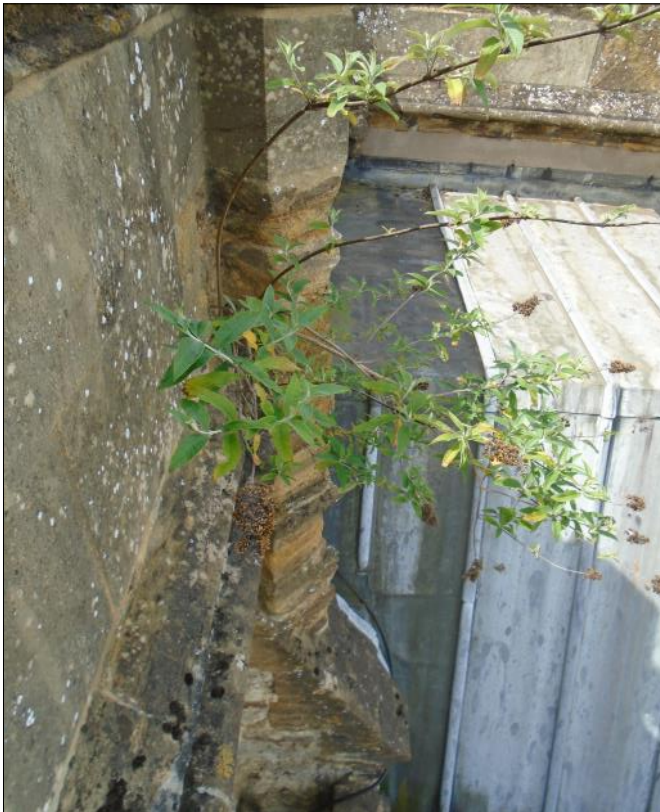
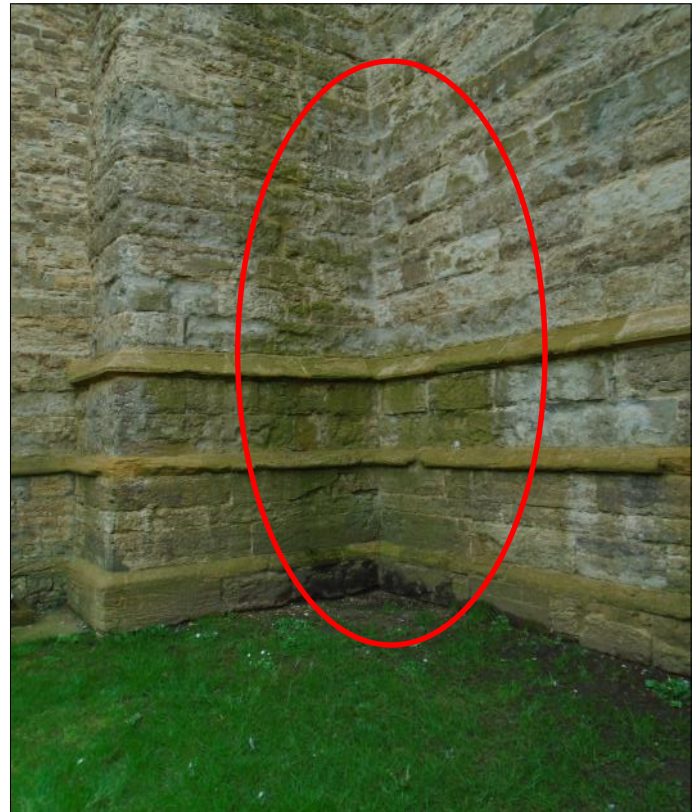
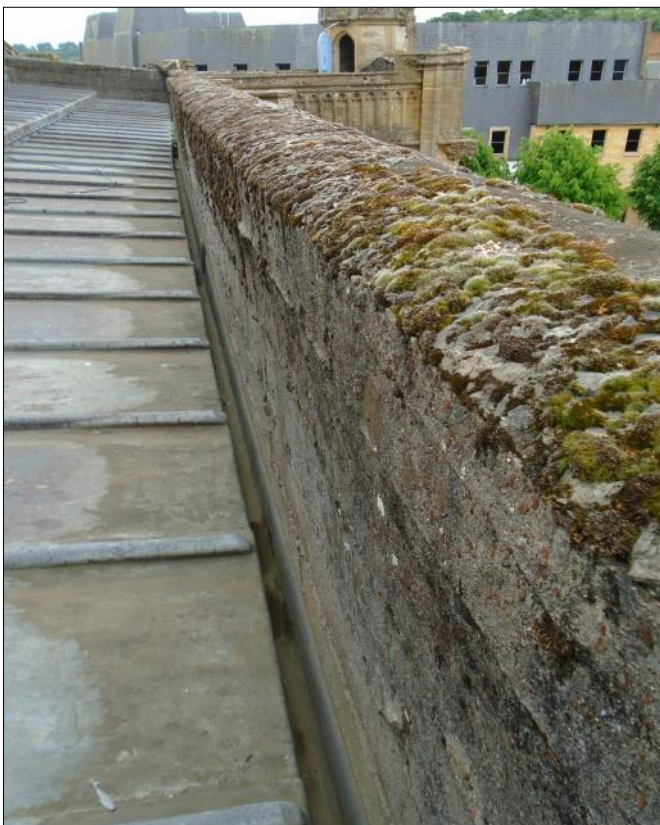
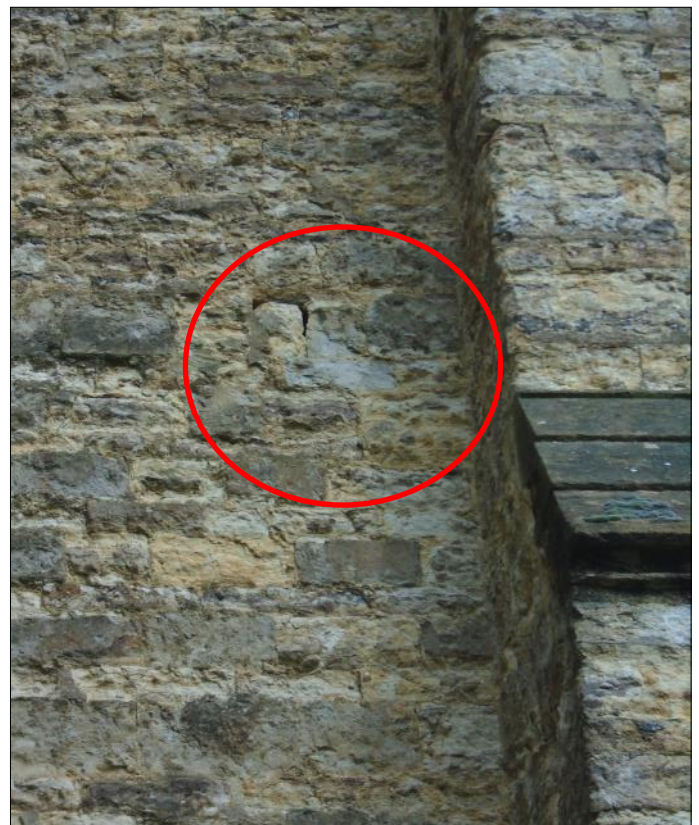
- Top left:** Remove buddleia from north parapet wall and point up.  
**Top right:** Note Micro Biological Growth (MBG) or algae below tower gargoyle and on low level walls.  
**Below left:** Concrete parapet facings are starting to deteriorate, remove moss and mortar repairs.  
**Below right:** Repoint failed area of wall on W face of S transept.

present time. One section of well-founded buddleia needs to be removed from the outside face of the choir north aisle around the north east corner.

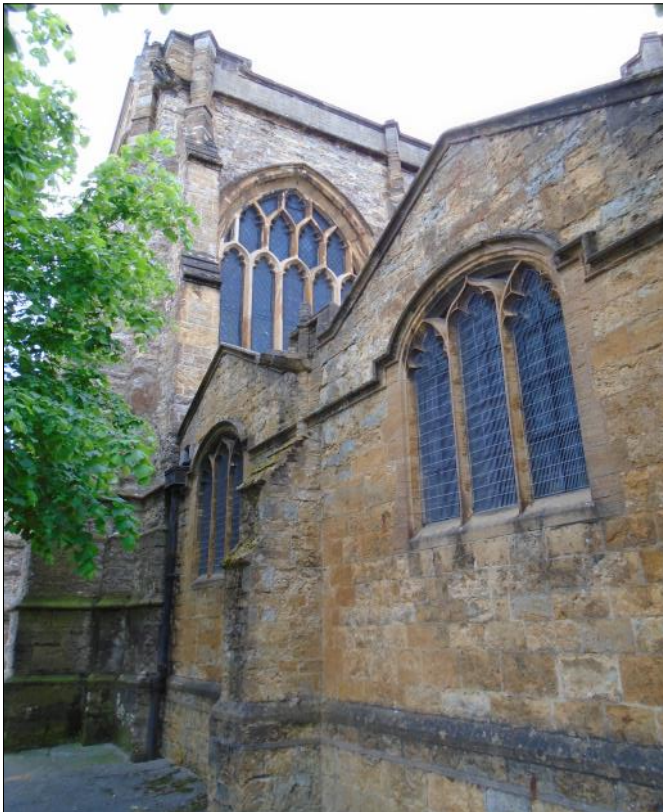
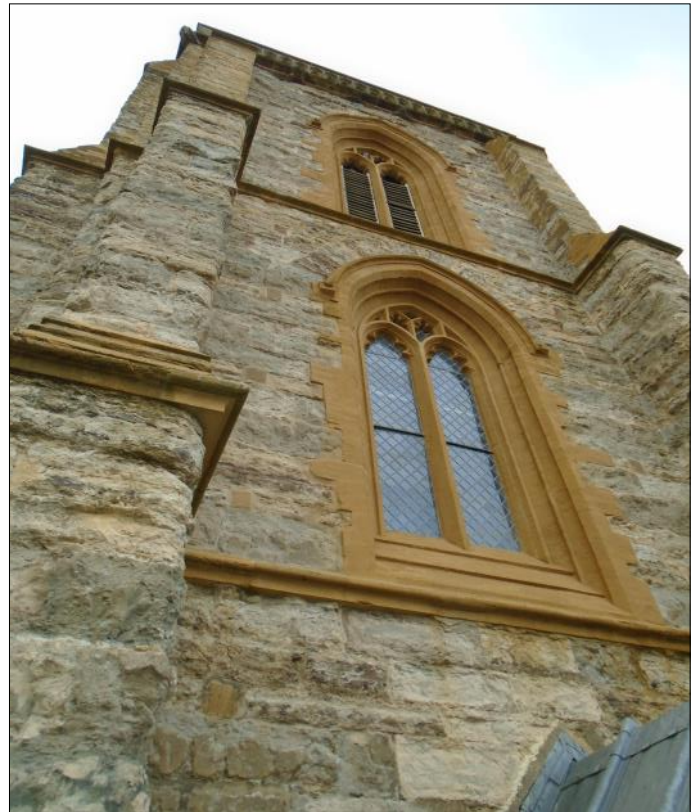
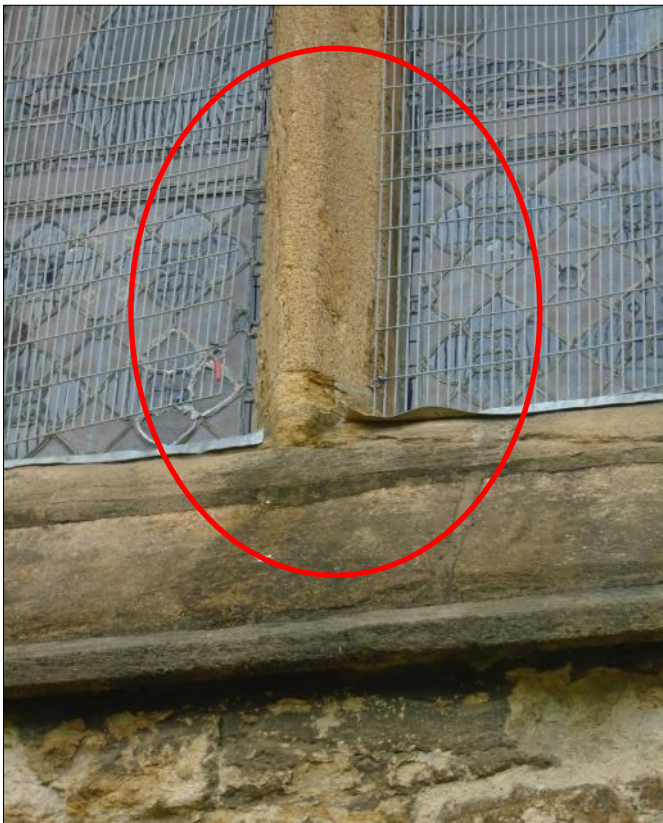
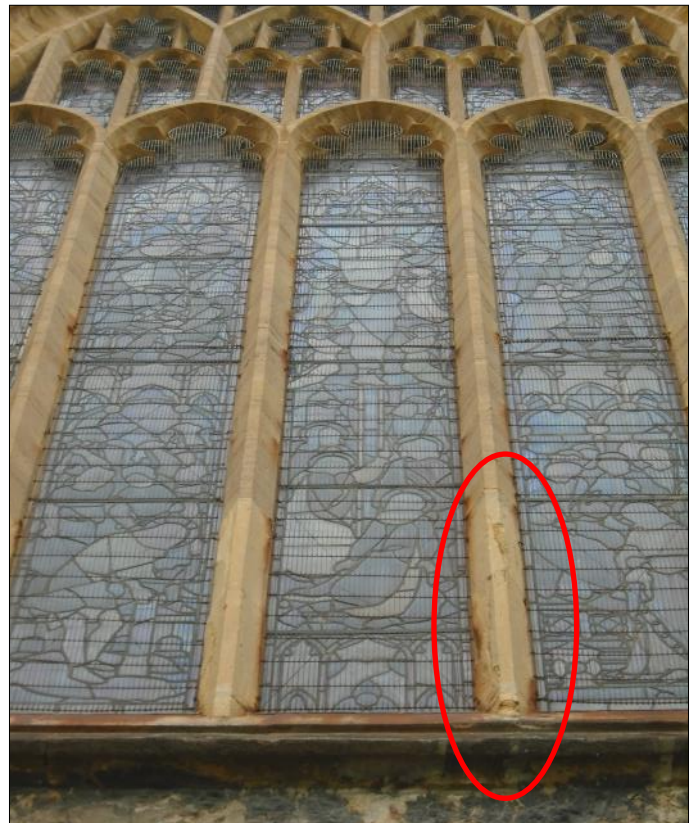
- Top left:** NE vestry walls are in poor condition in places.  
**Top right:** Tower walls remain in good condition following 2015 repairs.  
**Below left:** SE chapel, S window. Note loose wire guard on left and lifted lead cill.  
**Below right:** Further occasional repairs required to masonry mullions and tracery.

- 9.9. Vestry walls, particularly around the east elevation, are in poor condition in places and will require repair towards the end of the current quinquennium.

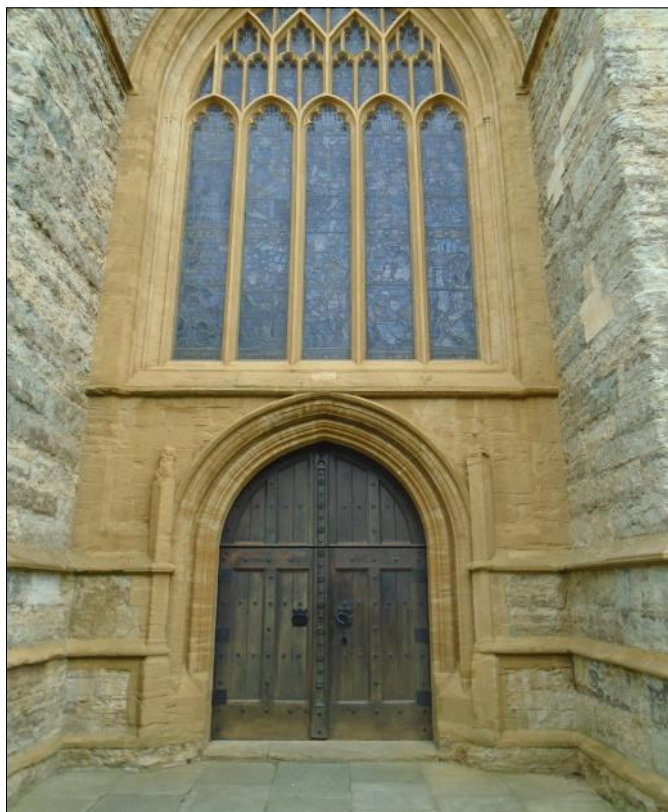
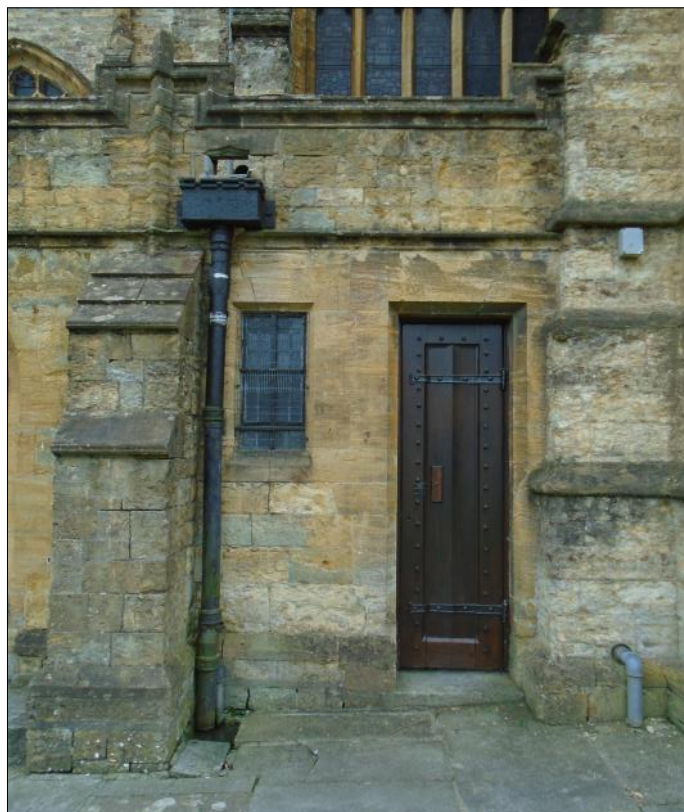
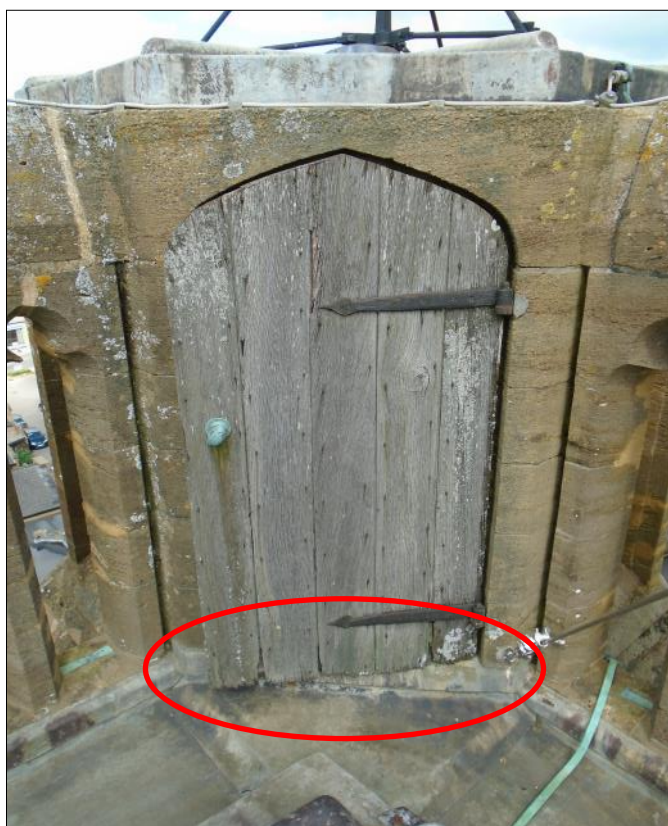
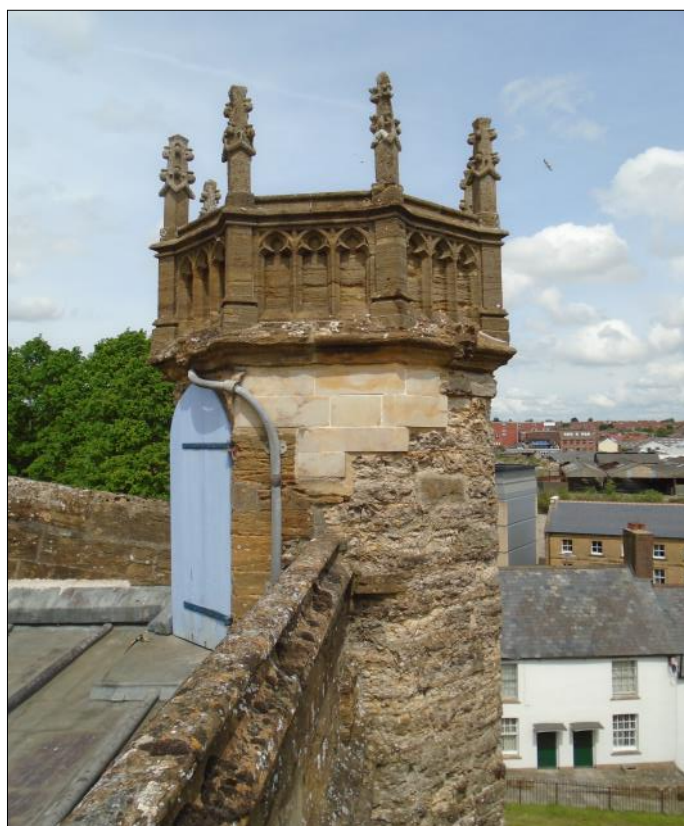
- Top left:** W window, door surrounds and door fully repaired in 2015.  
**Top right:** Vestry doors redecorated. Walls poor in place and downpipes require maintenance.  
**Below left:** Repair base of tower staircase door.  
**Below right:** Replacement stones to N vice turret aligned with medieval location.

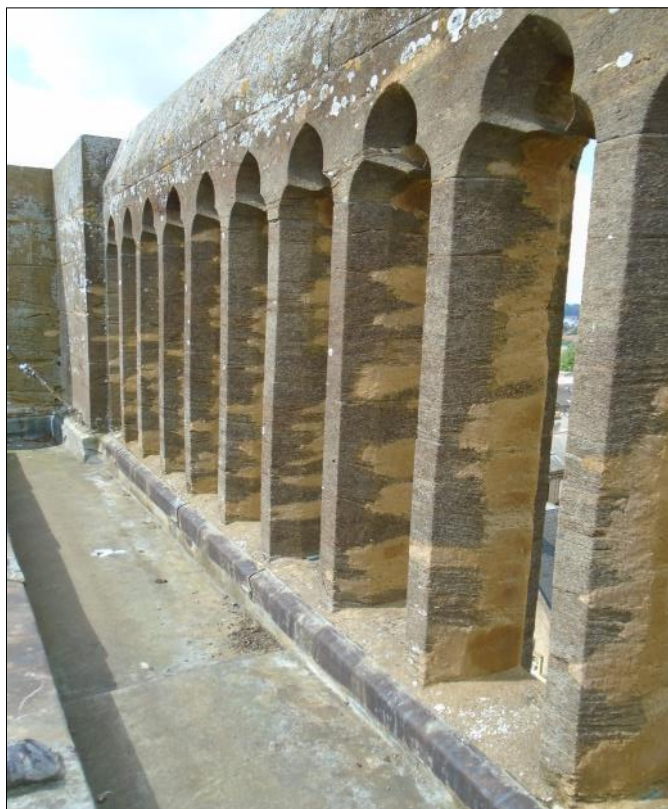
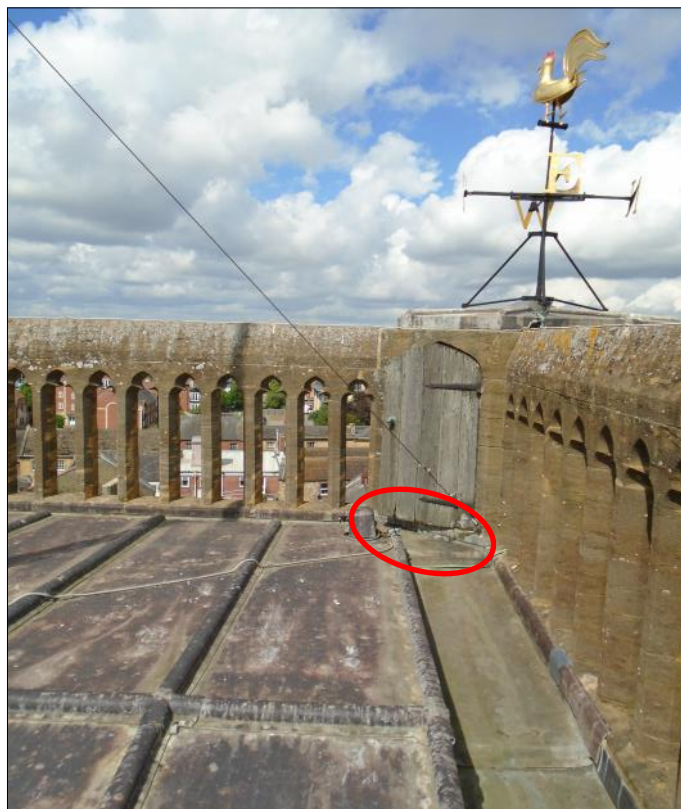
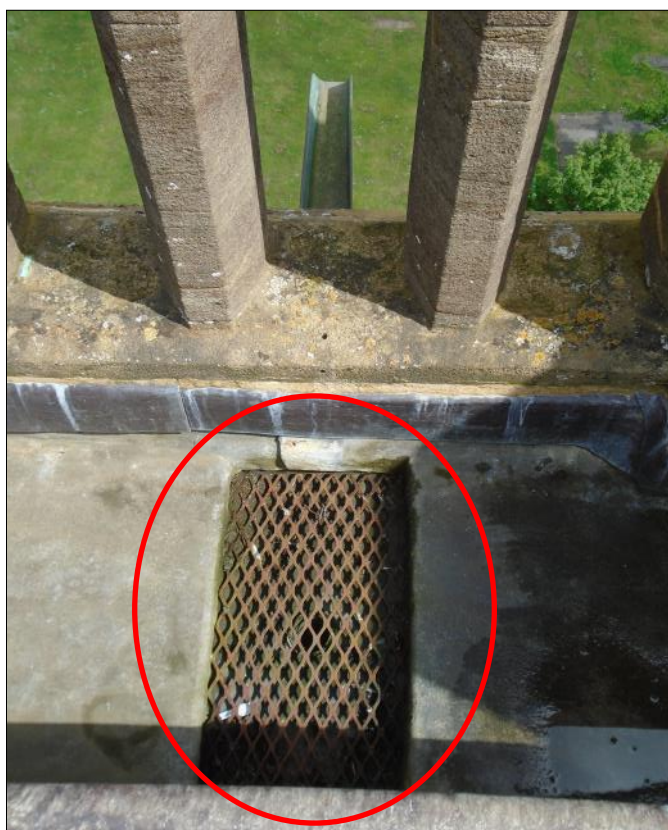
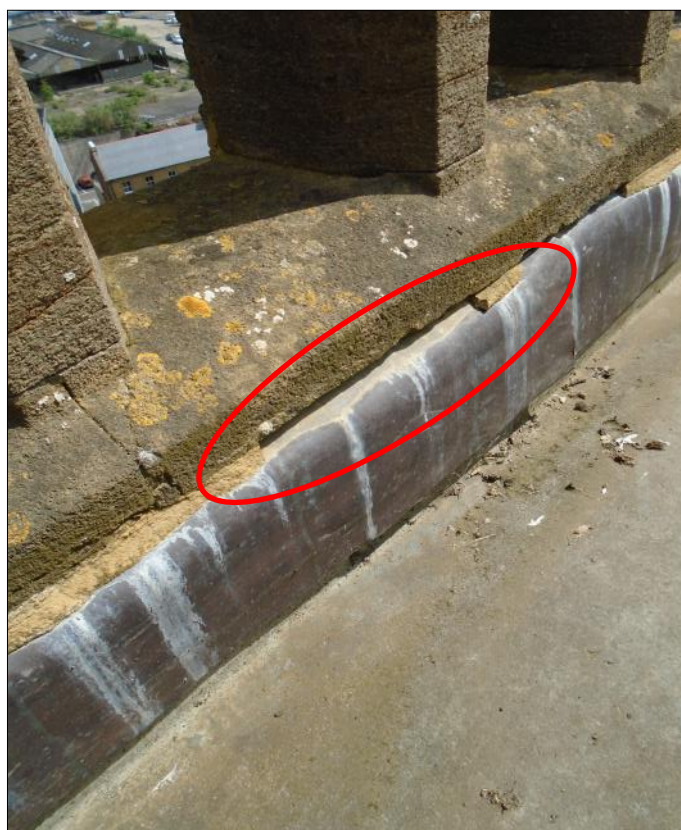
- Top left:** 2015 mortar repairs to tower parapets are weathering well.  
**Top right:** Repair vice turret door. Note gilded cockerel and painted stand.  
**Below left:** Lift gratings and clear tower sumps/outlets regularly.  
**Below right:** Replace missing mortar from tower parapet flashing groove.

- 12.4. Leadwork within the gutters is generally in fair condition, I noted a split immediately adjacent to the vice turret door and a further split at the intermediate step on the north side. Local repairs are required.

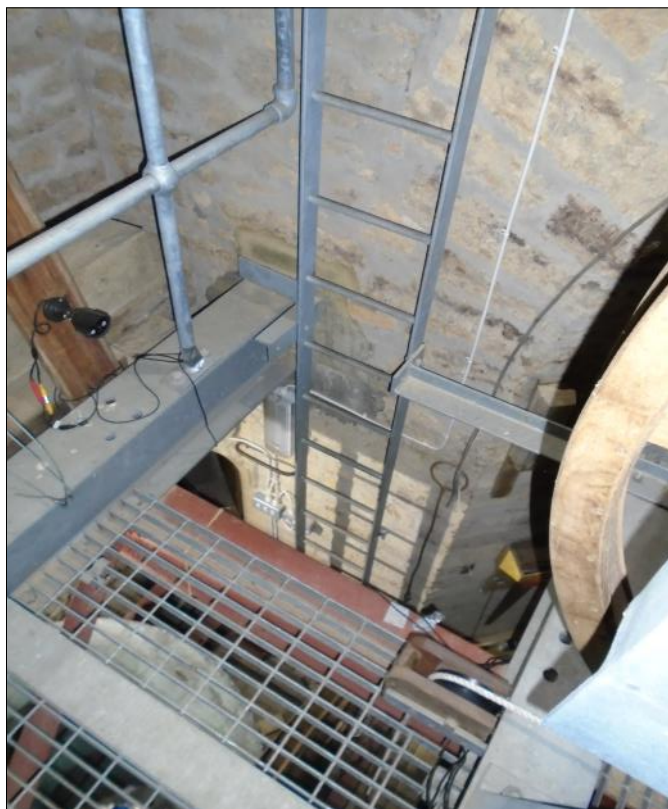
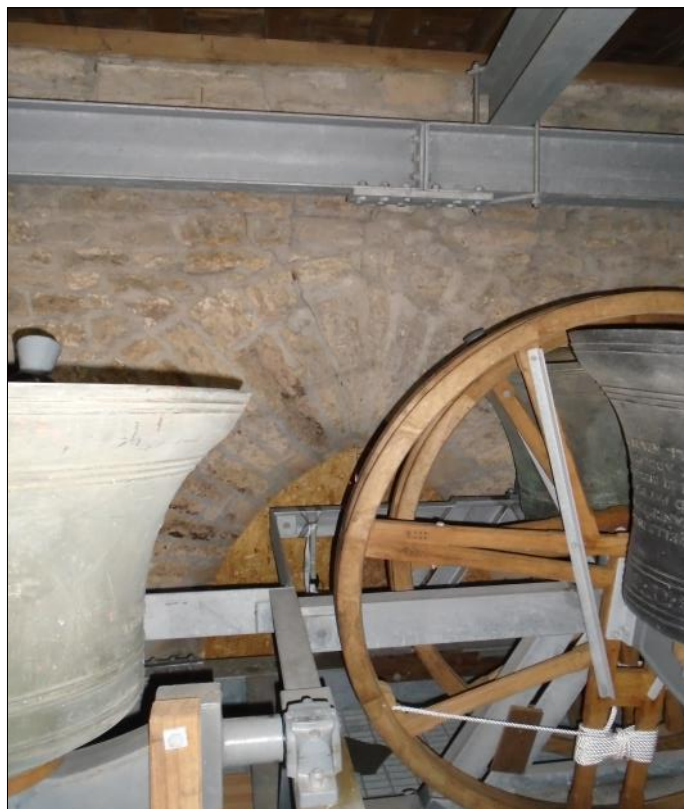
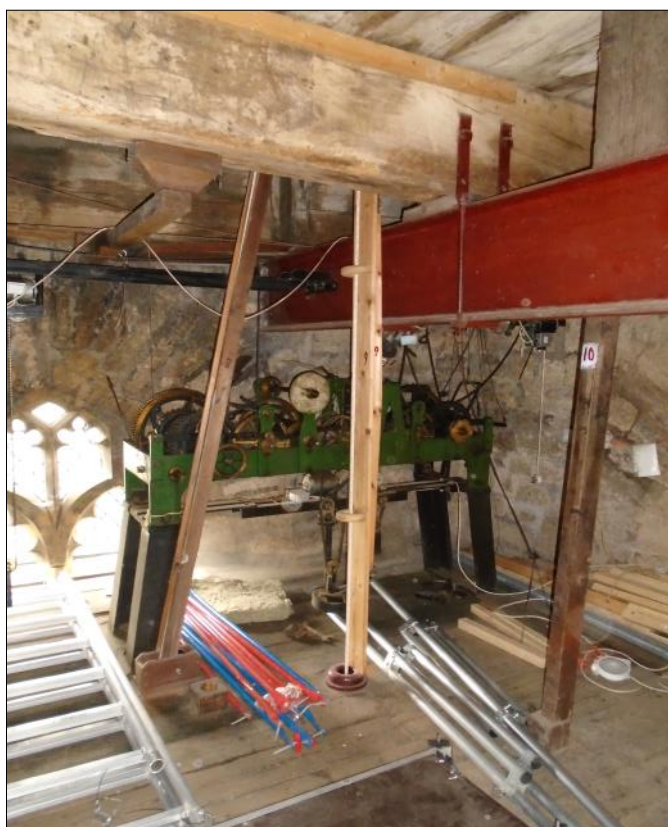
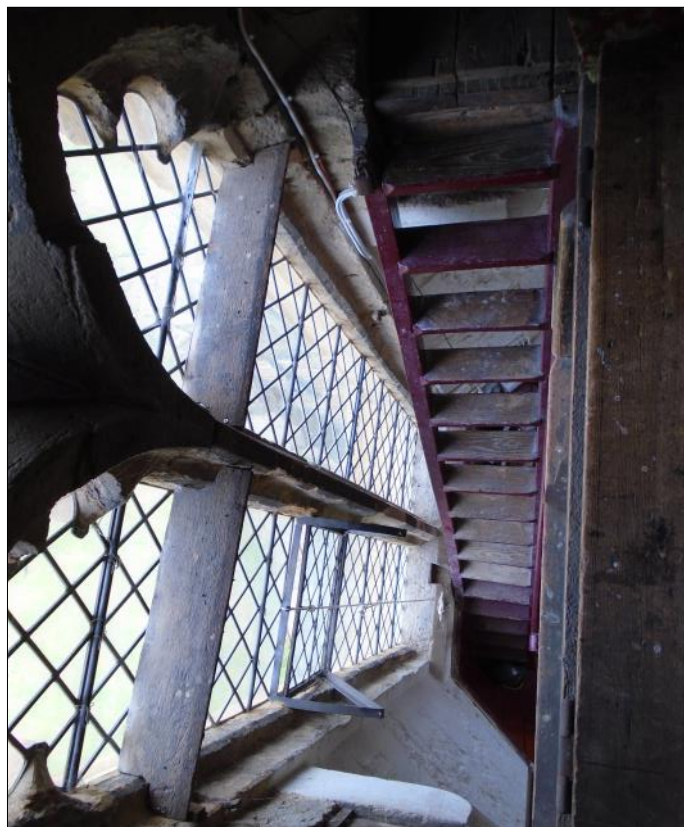
- Top left:** New grillage and access to upper bell frame is major improvement.  
**Top right:** Bells were up limiting safe access to belfry.  
**Below left:** Some local woodworm treatment required to clock chamber.  
**Below right:** Access ladder from belfry to clock chamber, tread carefully!

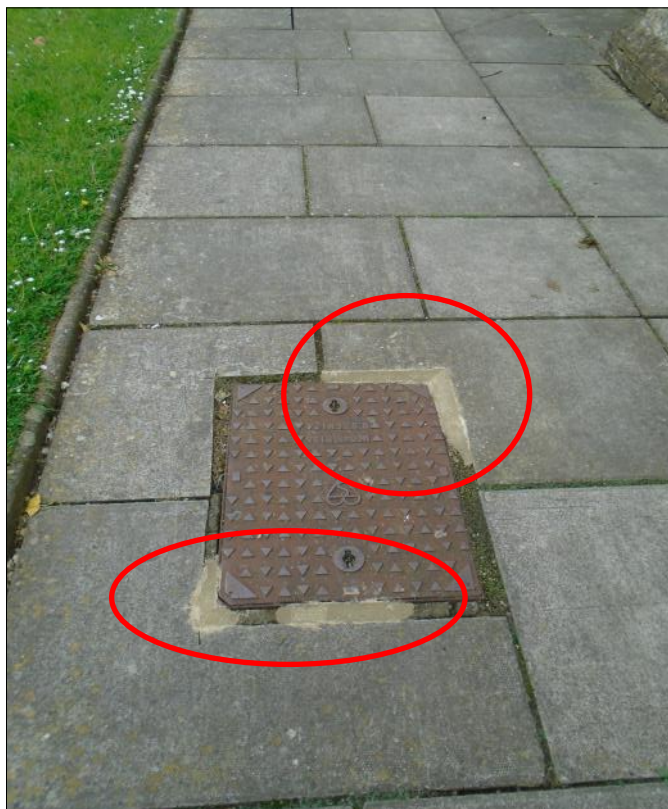
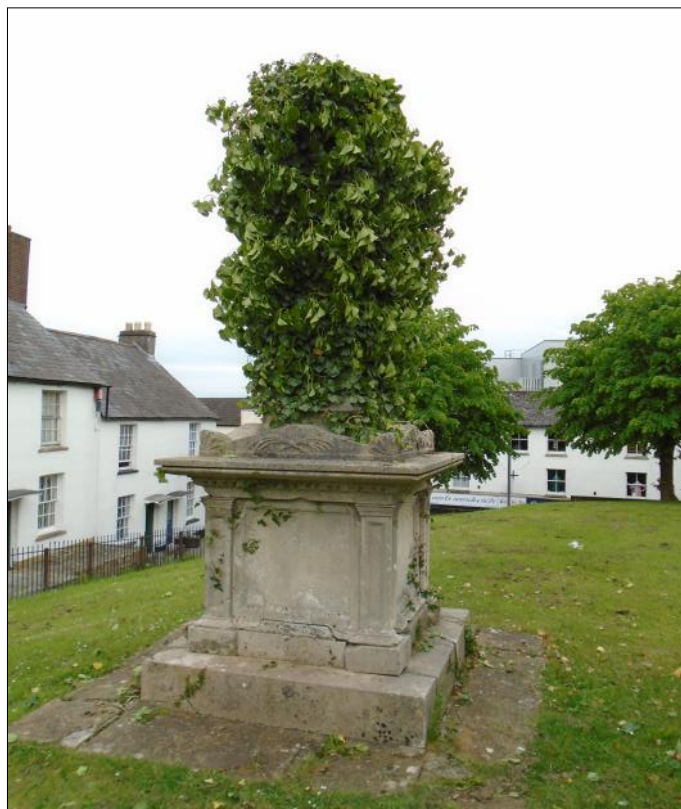
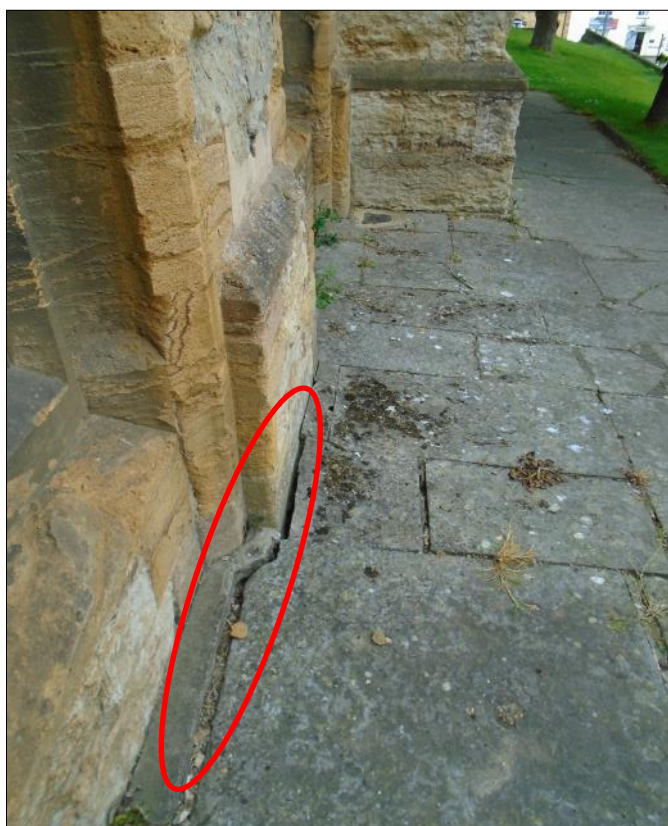
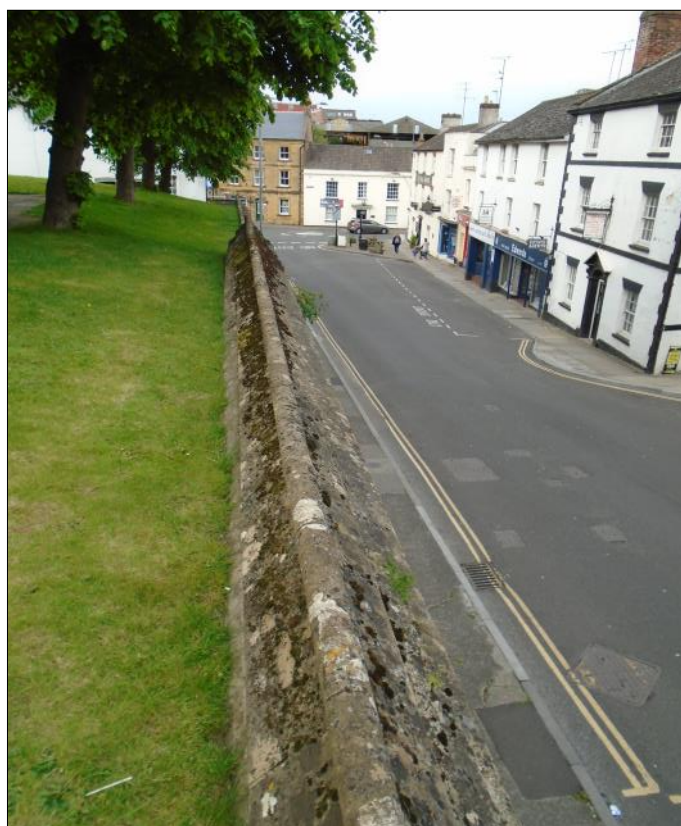
- Top left:** Uneven pavings and covers need more mortar flaunching.  
**Top right:** Kill, leave to die and remove ivy from churchyard monuments. This monument has already been ring-barked.  
**Below left:** Point open cracks to paving around east end.  
**Below right:** Concerns remain over unguarded falls along east retaining wall of churchyard.
