# YEOVIL St John the Baptist

**Quinquennial Inspection for the Year 2017**

Inspection of Churches Measure 1955  
Quinquennial Inspection Report  
Diocese of Bath and Wells

May 2017

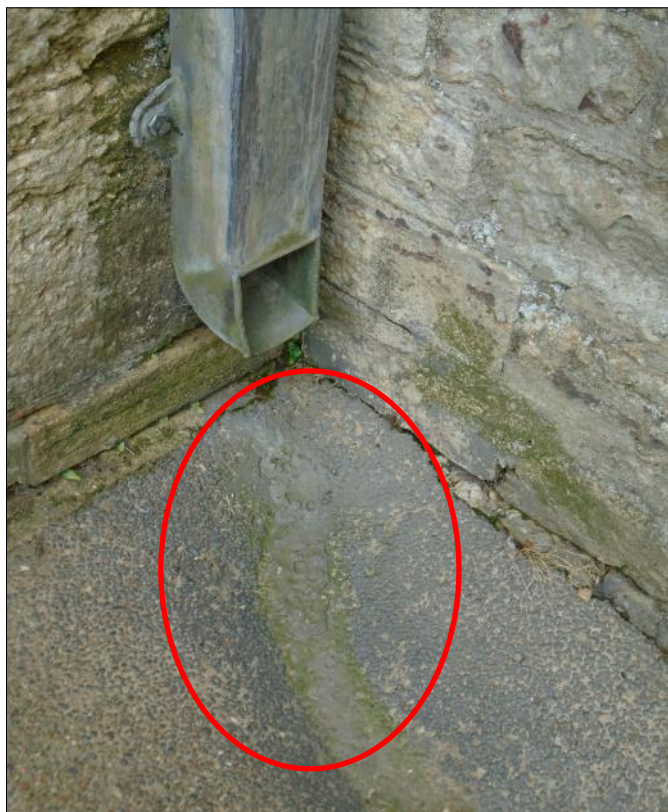
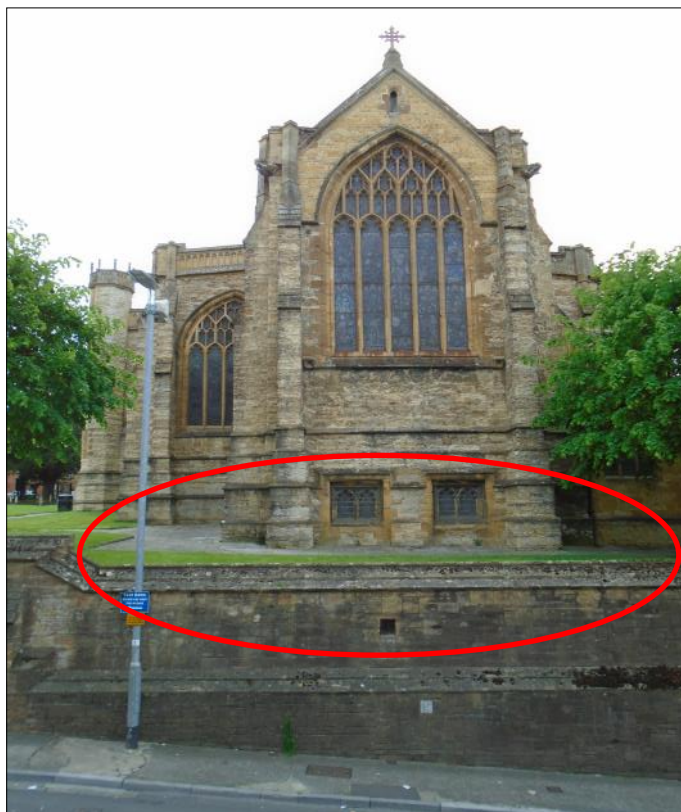
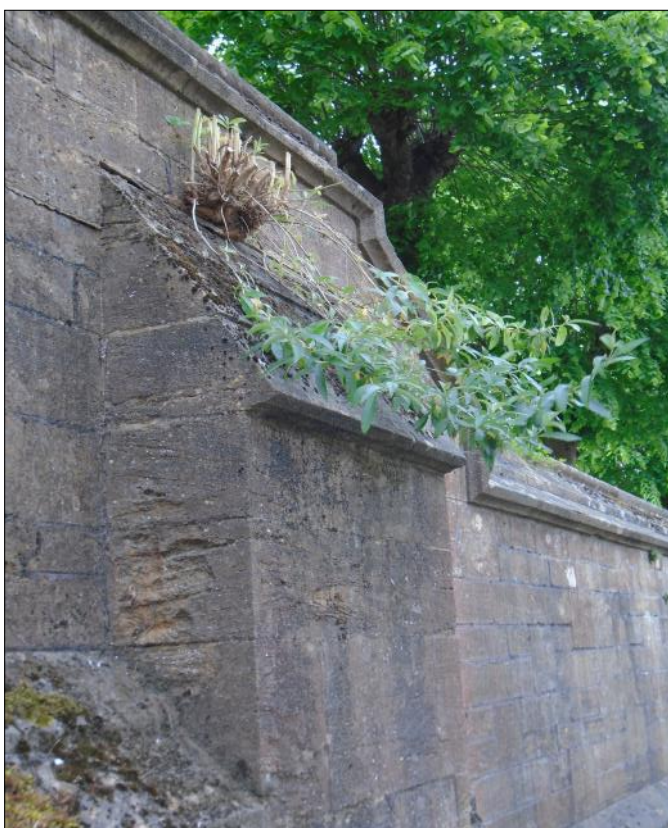
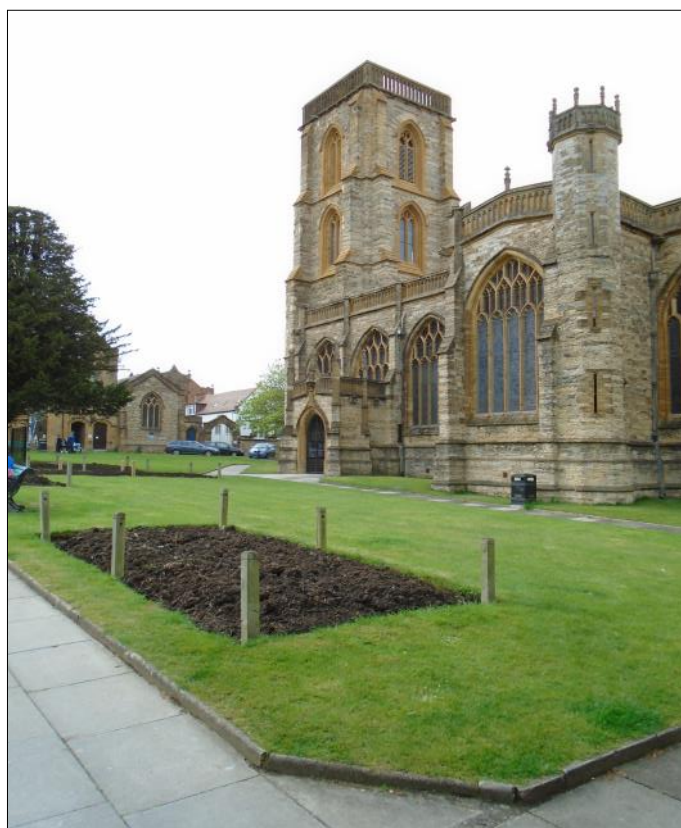
- Top left:** Detail of open joints around base of downpipes, point up.  
**Top right:** General view highlighting proximity of east gable to retaining wall.  
**Below left:** Vegetation growing from churchyard east retaining wall.  
**Below right:** General view from SE towards restored tower.

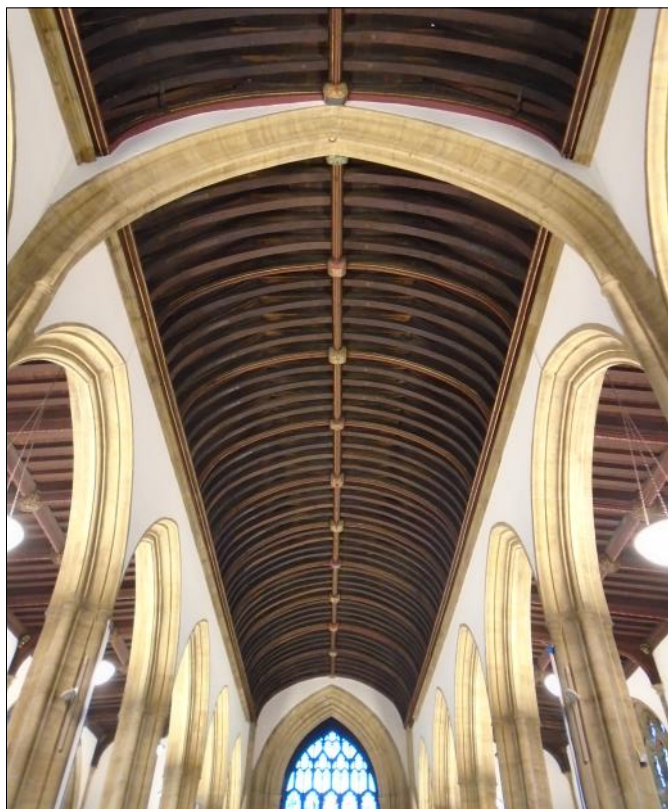
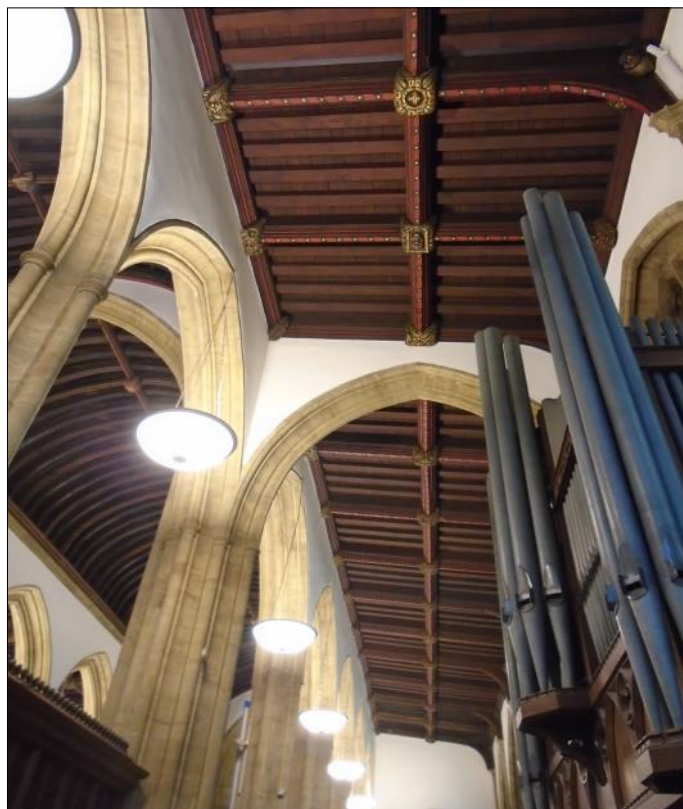
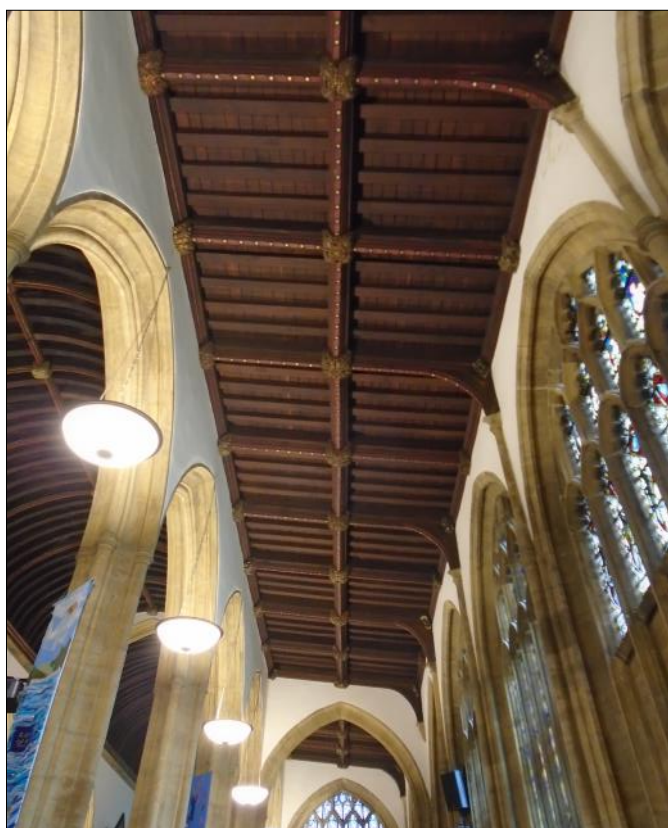
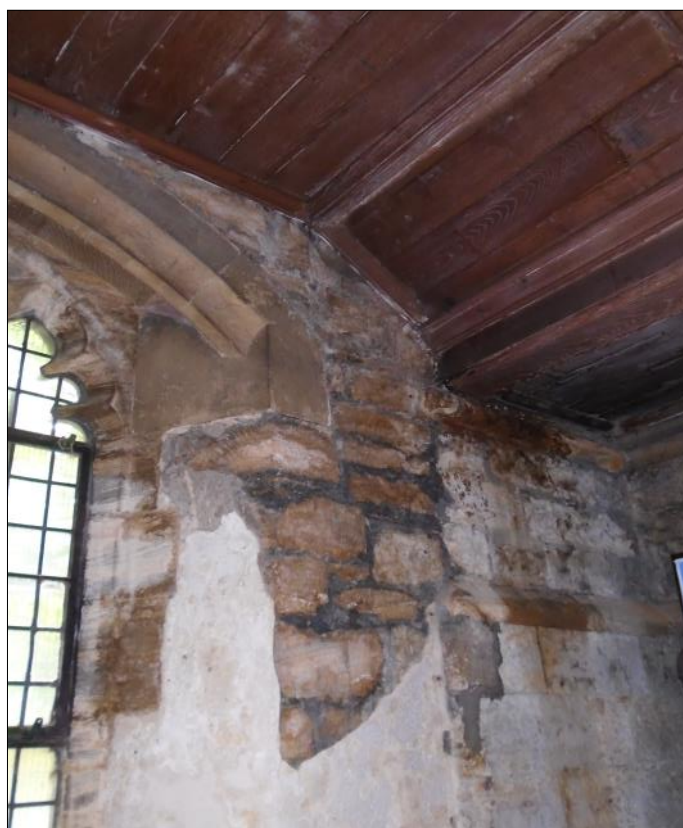
- Top left:** Vaulted nave ceiling looking W towards tower arch, chancel arch over. Good condition.  
**Top right:** NE choir and N nave aisle ceilings. Good condition throughout.  
**Below left:** S aisle ceiling also sound and in good condition.  
**Below right:** Recent water damage to E vestry wall now drying out.

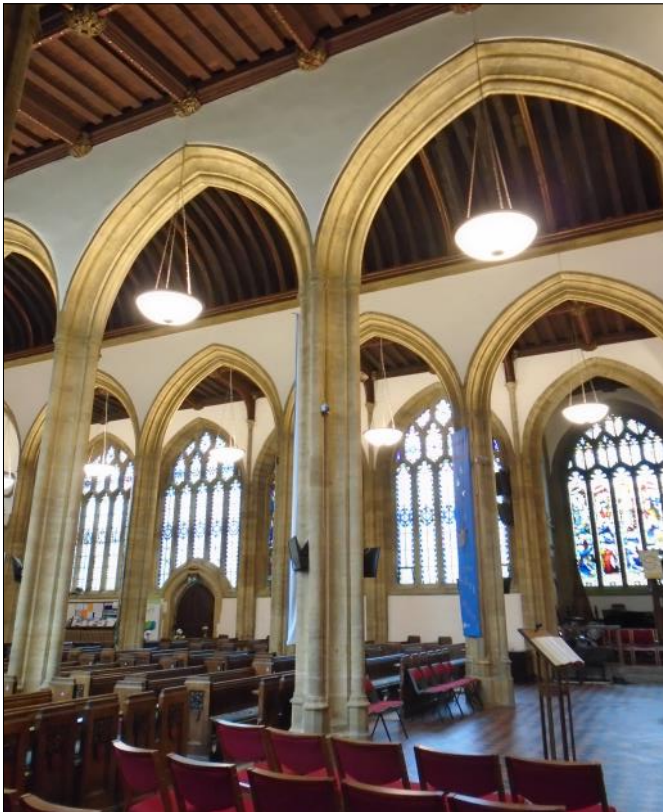
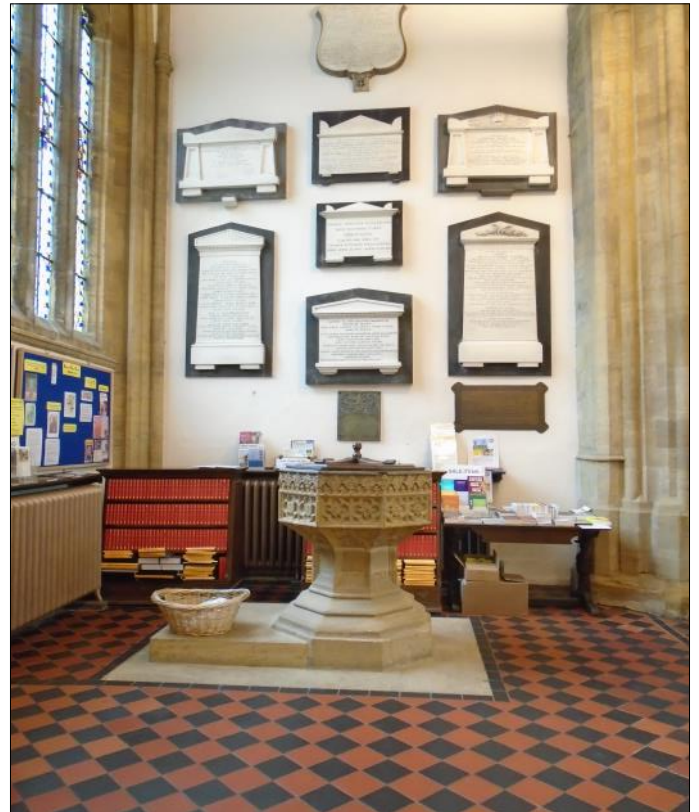
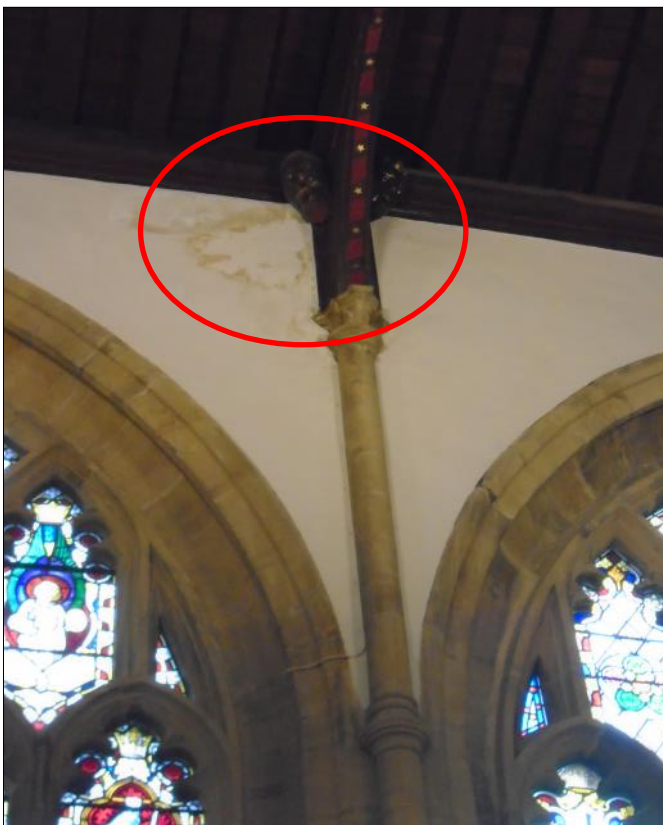
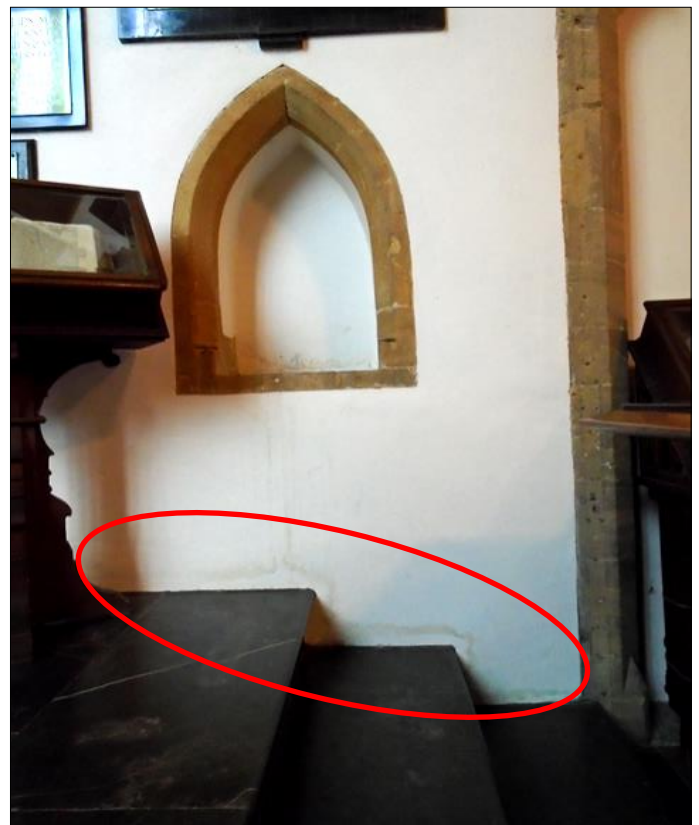
- Top left:** Aisle arcades and plastered panels are all sound.
- Top right:** Monuments on the W wall of the S aisle are grouped together and remain in good condition.
- Below left:** Water damage from flooded parapet gutters is slowly drying out.
- Below right:** Damp 'tide mark' to chancel steps.

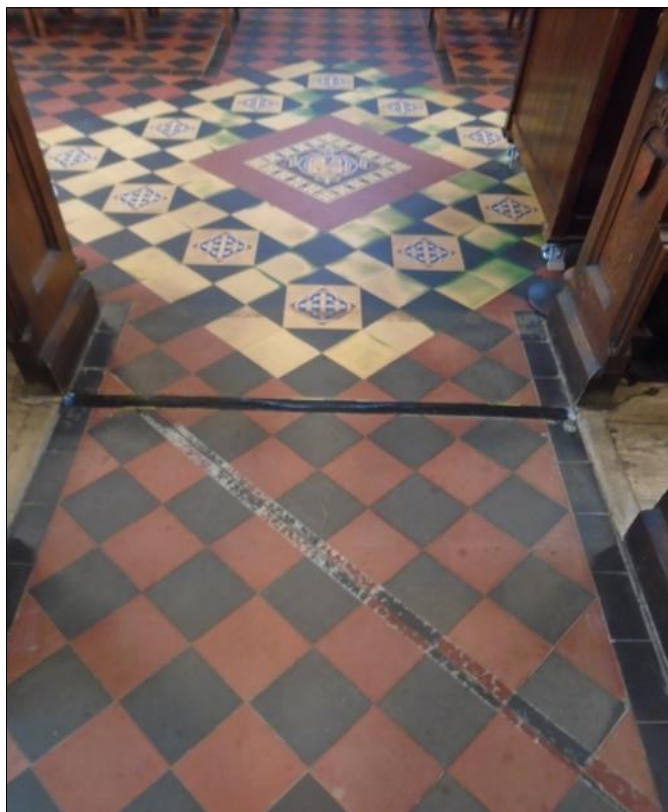
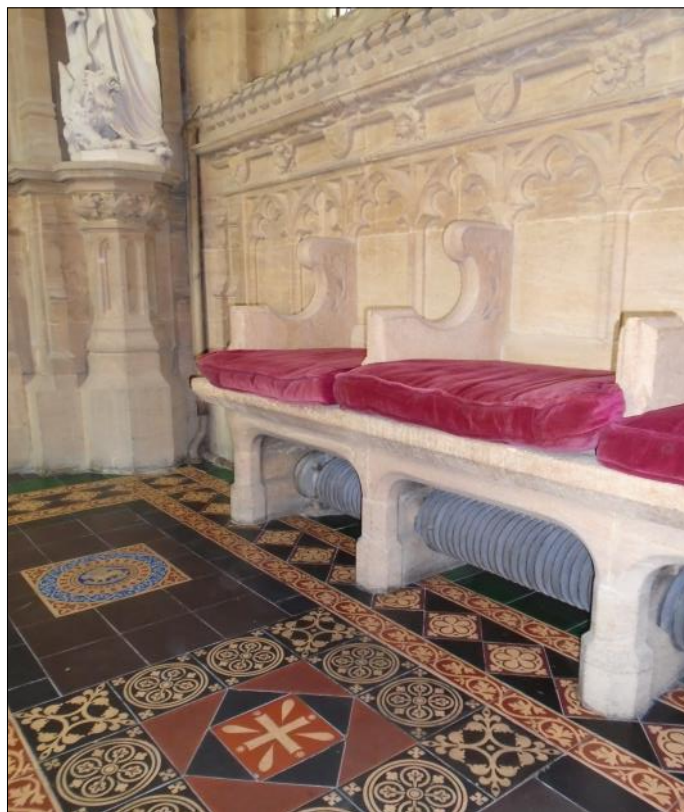
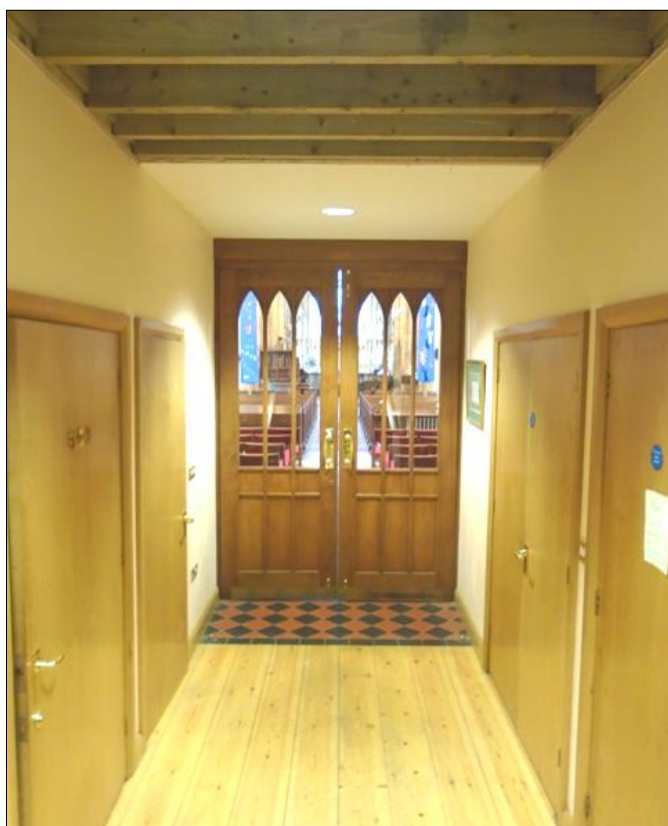
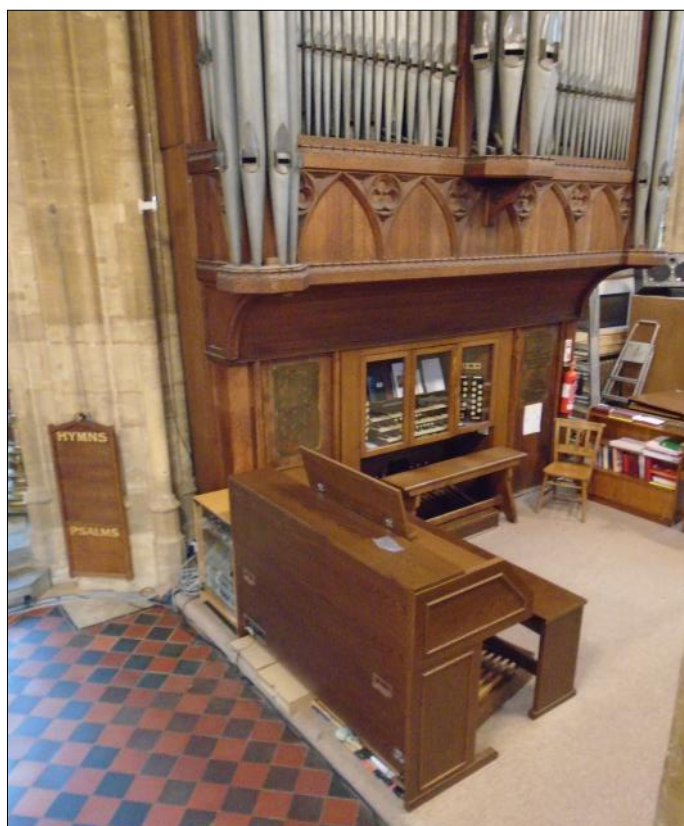
- Top left:** Encaustic tiled floors are 'wearing out', beware of trailing leads.  
**Top right:** Decorative masonry and stone benches within chancel.  
**Below left:** Lavatory accommodation below tower includes disabled facilities.  
**Below right:** Rubber backed carpet underlay should be replaced at some stage.

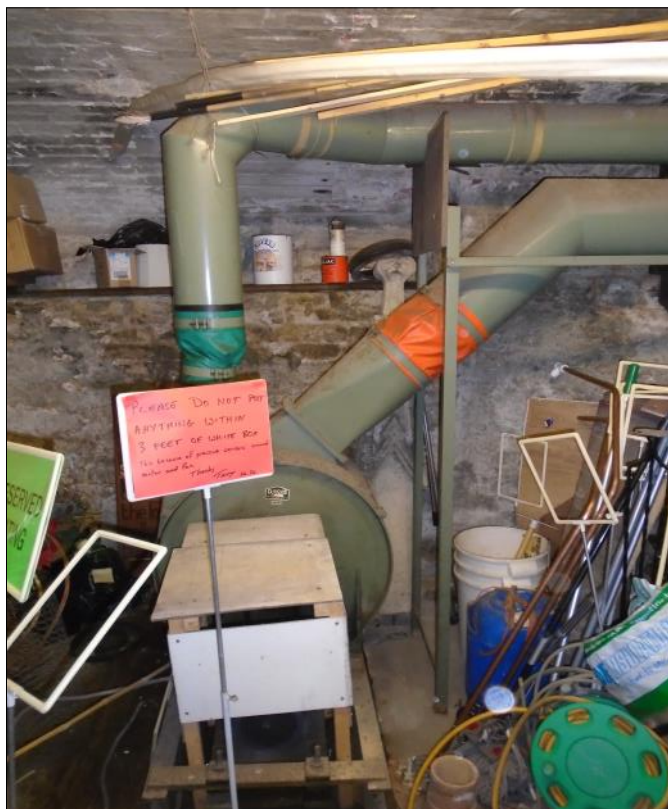
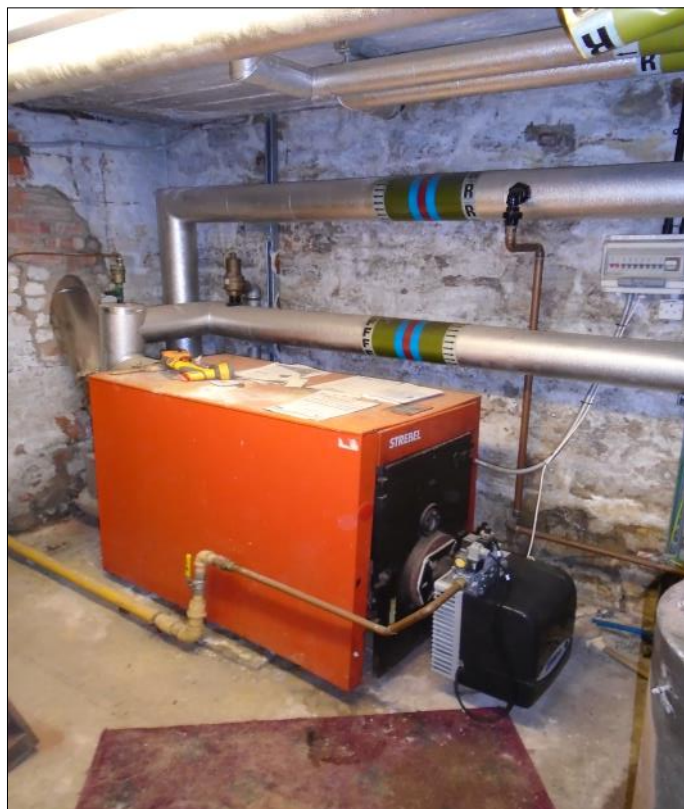
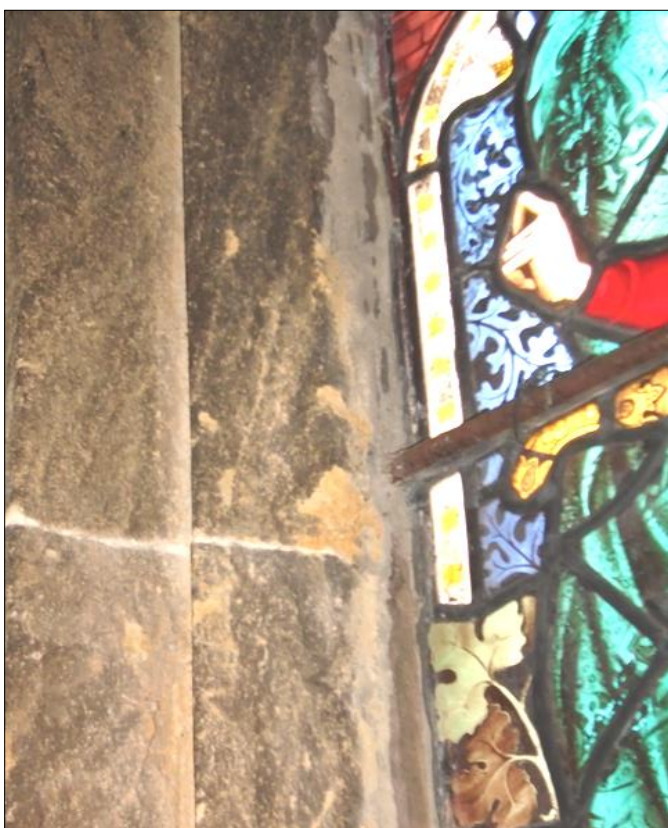
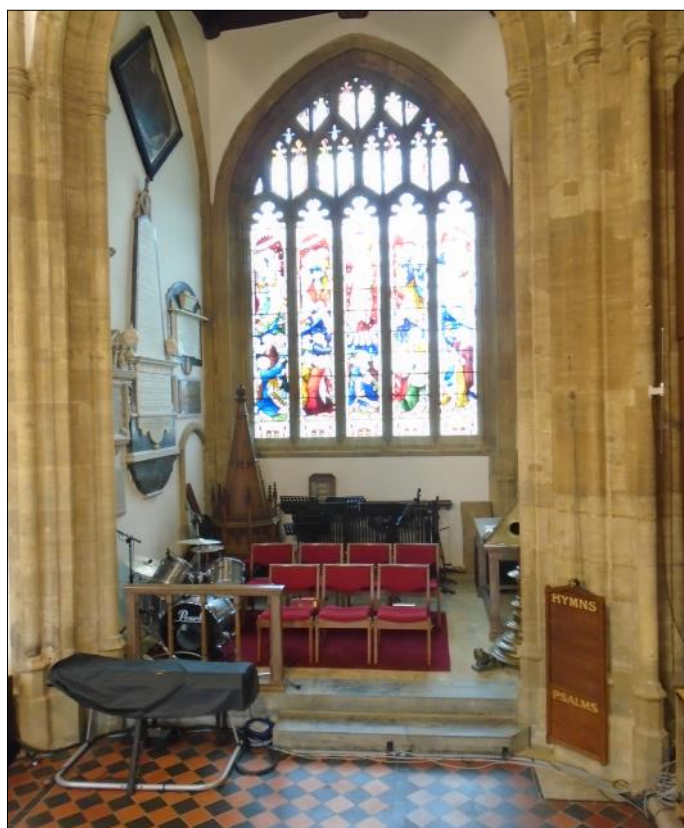
- Top left:** Blower fan in chamber below, some housekeeping would be helpful.  
**Top right:** Boiler, pumps and insulated pipework all in good order.  
**Below left:** Minor decay from corroding saddle bars, monitor.  
**Below right:** N transept stores musical instruments and font cover.

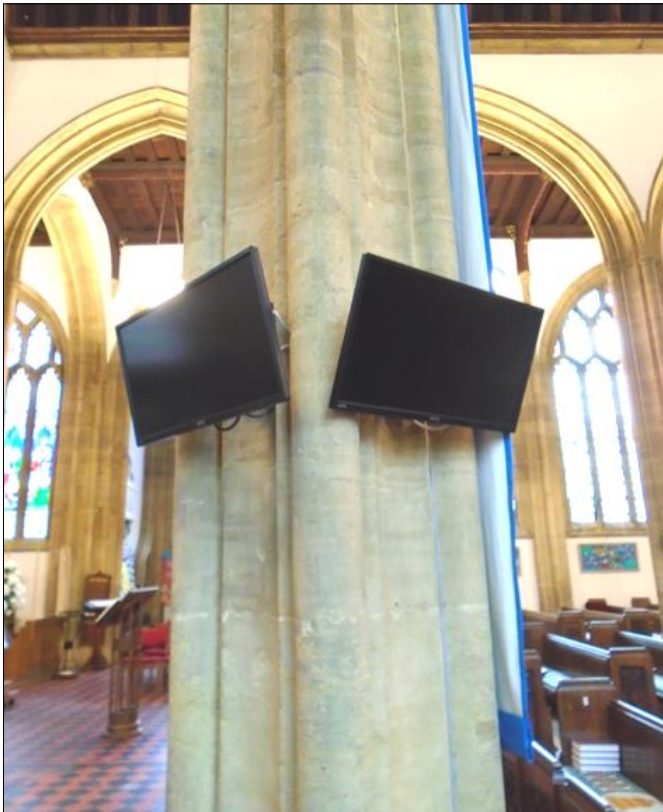
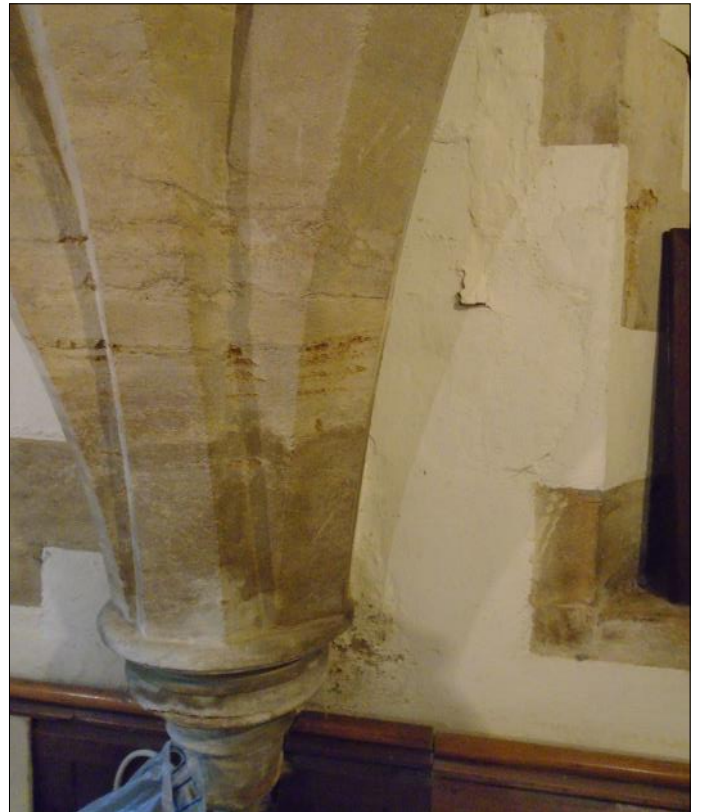
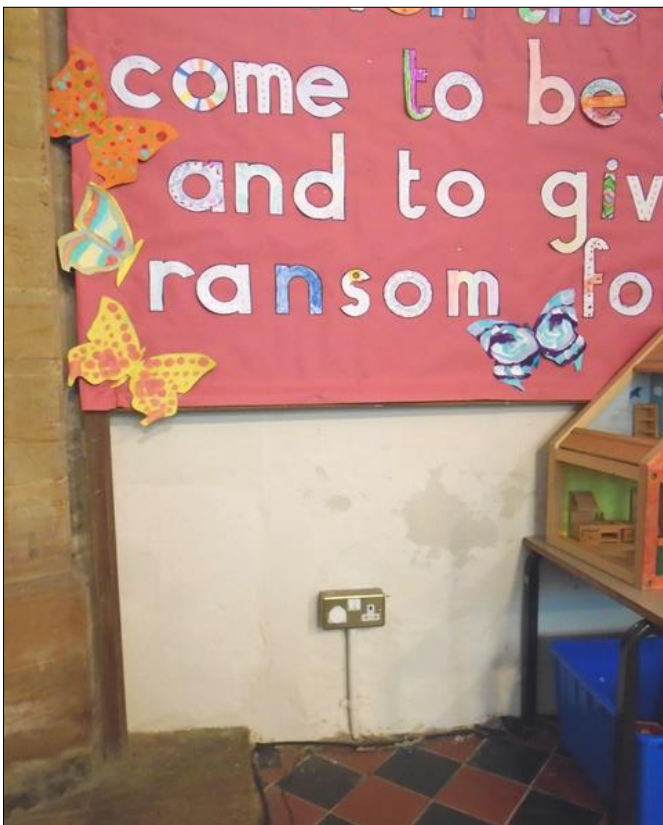
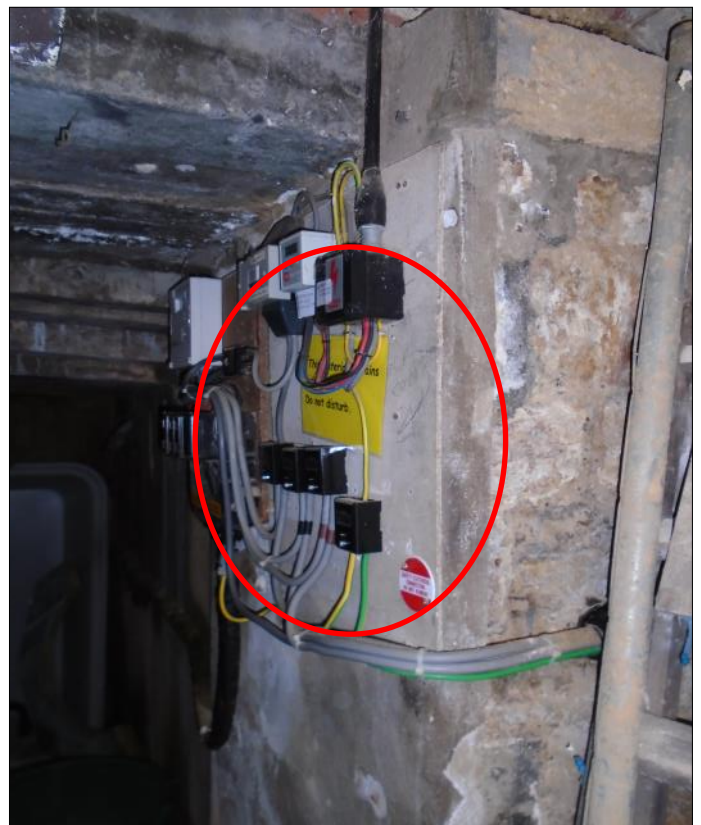
- Top left:** The visual appearance of landscape TV screens could be improved by mounting portrait.
- Top right:** Surface deterioration in crypt walls, monitor and touch-in.
- Below left:** Damp in base of S transept S wall, monitor. Space banner off the wall.
- Below right:** Electrical boards on asbestos backing board below organ chamber.
